FACADE
REHABILITATION
PRE-DESIGN
INVESTIGATION AND
CONDITIONS
ASSESSMENT

Nativity of the Blessed
Virgin Mary Chapel
Flagstaff, Arizona
1 May 2017

SGH Project 167283

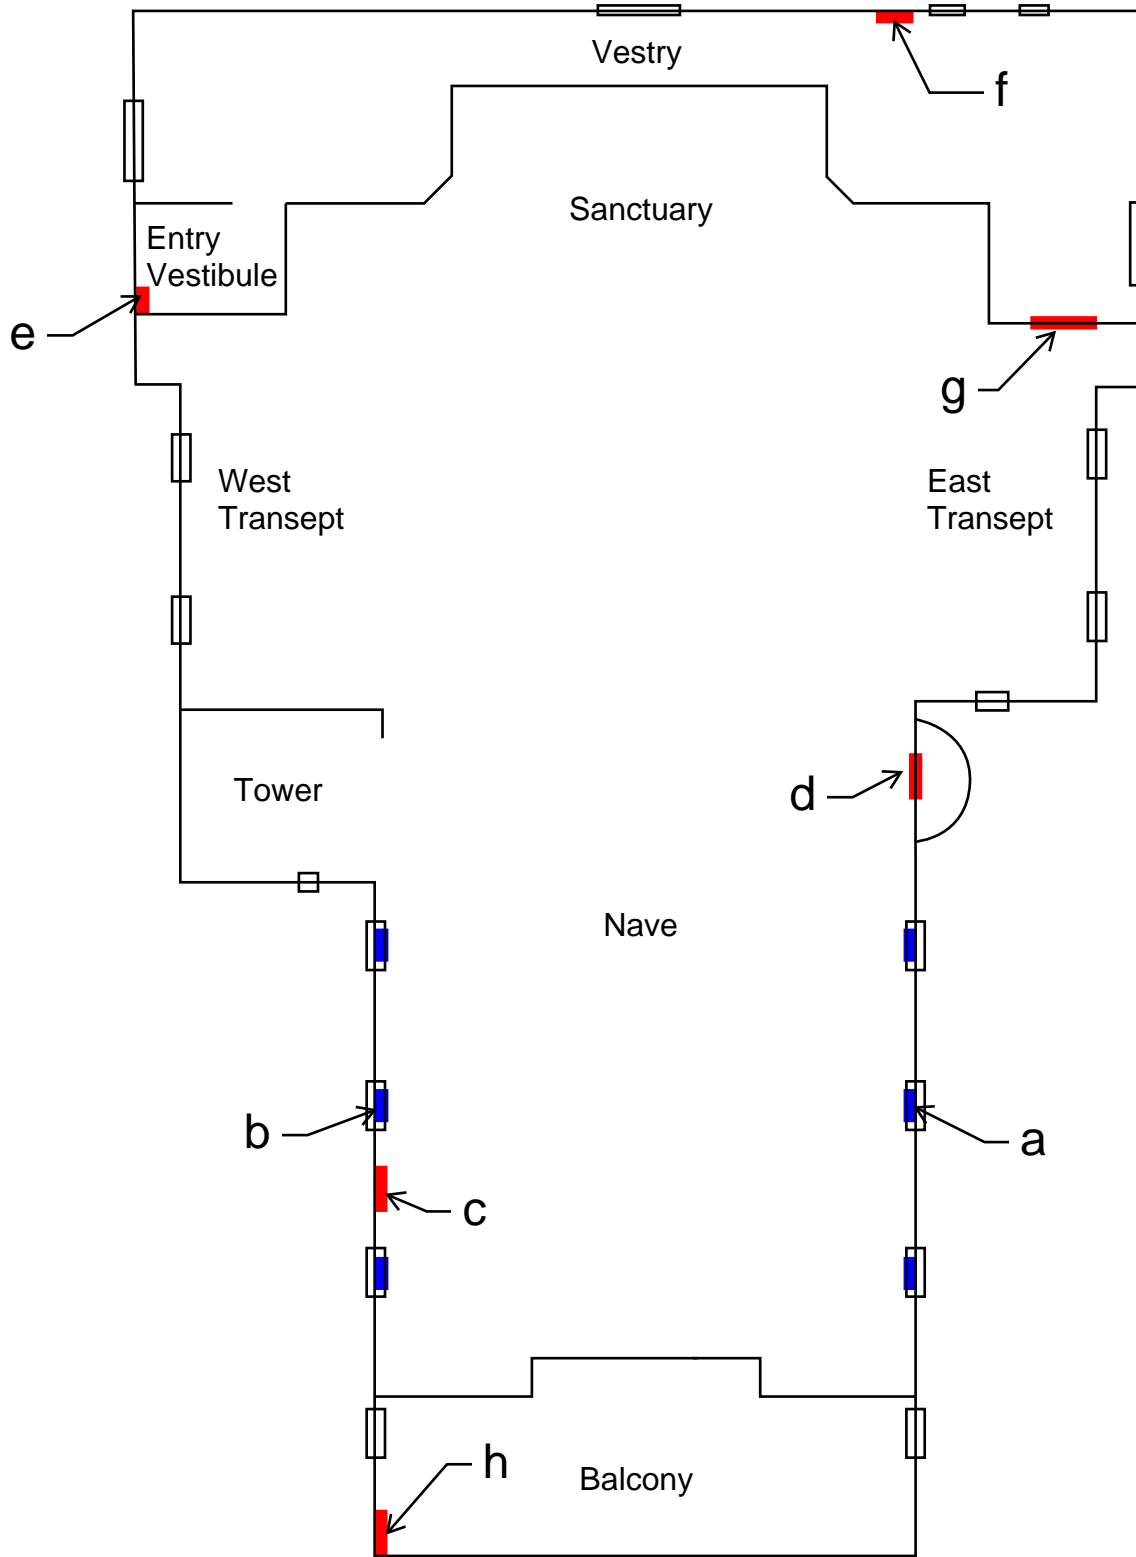
Figure #1 - Floor Plan

- Water stains on the interior walls below the lancet windows on the east and west elevations of the nave and balcony (Photos 5 and 6; Figure 1, (a, b)).

- Paint peeling and staining on the surface of the interior wall and coating at the west elevation of the nave (Photo 7; Figure 1, (c)).
- Water damage at the ceiling of the east alcove enclosing the baptismal font (Photo 8; Figure 1, (d)). Based on discussion with building maintenance personnel, we understand portions of the plaster previously fell from the ceiling at this location due to water damage (Photo 9).

- Staining and paint peeling at the ceiling and walls of the west entry vestibule (Photo 10; Figure 1, (e)).
- Minor staining and paint peeling on the northeast ceiling of the vestry adjacent to the support column (Figure 1, (f)).

- Horizontal cracks in the walls throughout the nave (Photo 11).
- Water damage and deteriorated drywall behind a statue in the east transept (Photo 12; Figure 1, (g)).

- Water damage and staining at the southwest corner of the balcony wall (Photo 13; Figure 1, (h)).

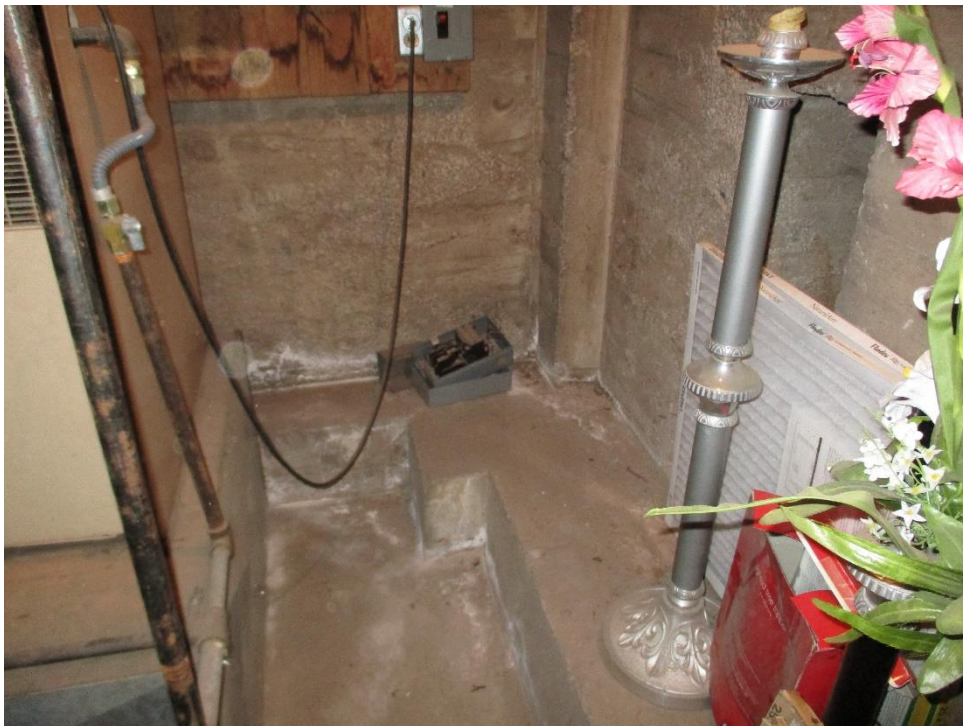
Photo 4

- Efflorescence and water stains on the basement walls and floor (Photo 4).

Efflorescence staining in basement.

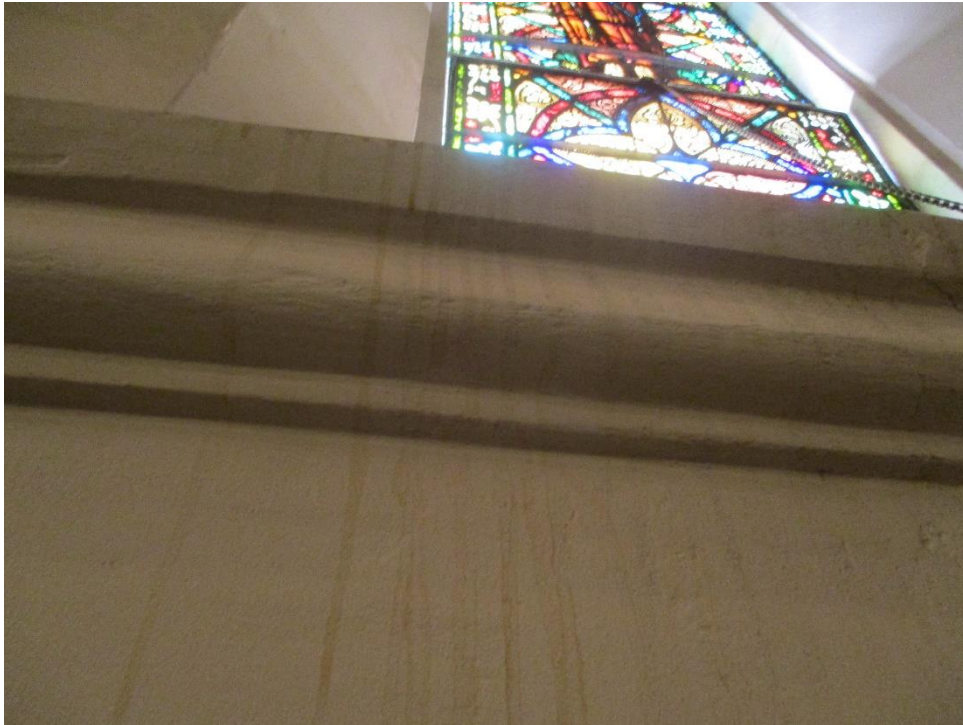
Photo 5

Staining on wall below lancet window.

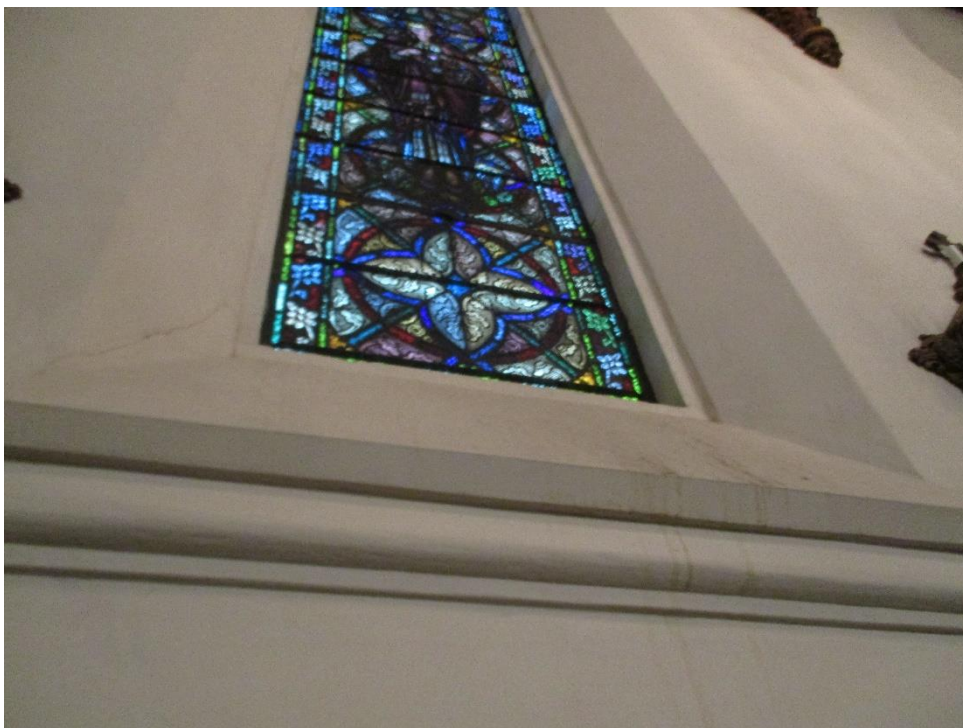
Photo 6

Staining on wall below lancet window.

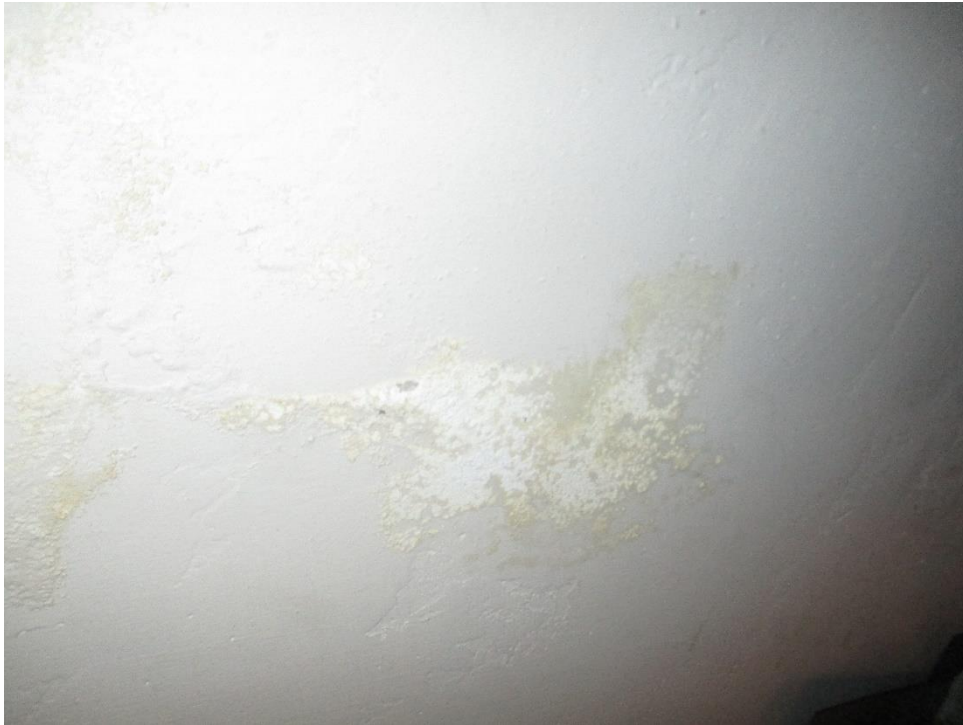
Photo 7

Paint peeling and staining on the west wall of the Nave.

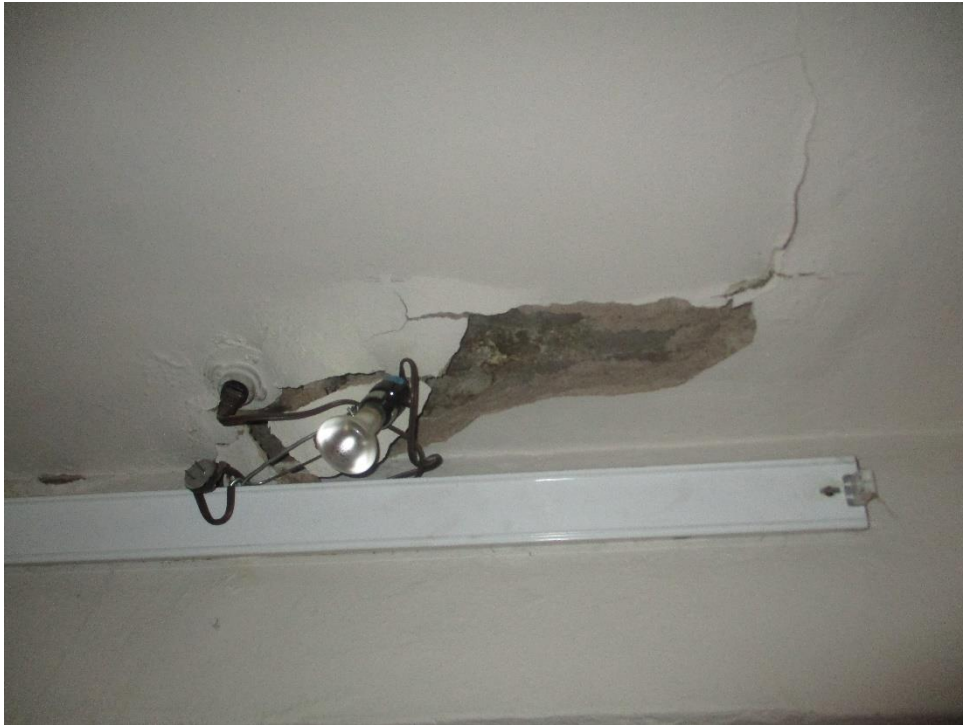
Photo 9

Water damaged plaster at baptismal alcove.

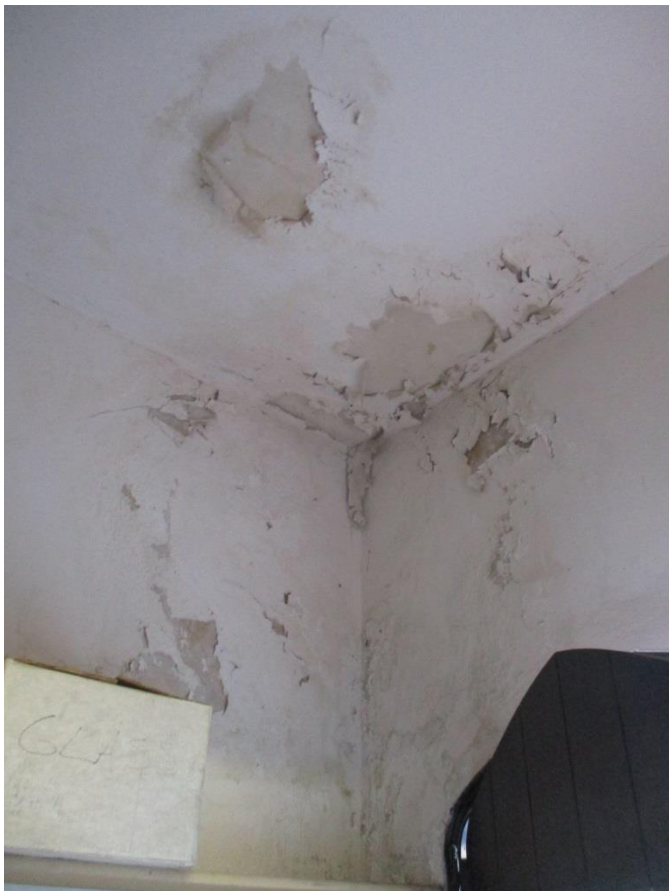
Photo 10

Staining and paint peeling at the northwest entry vestibule.

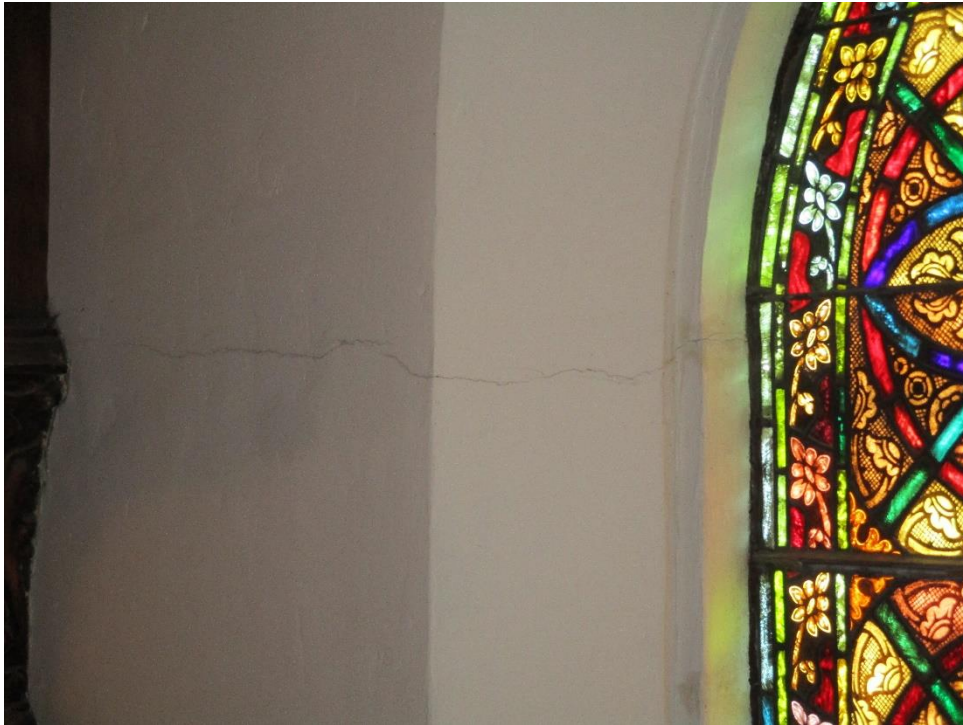
Photo 11

Typical horizontal crack in plaster wall.

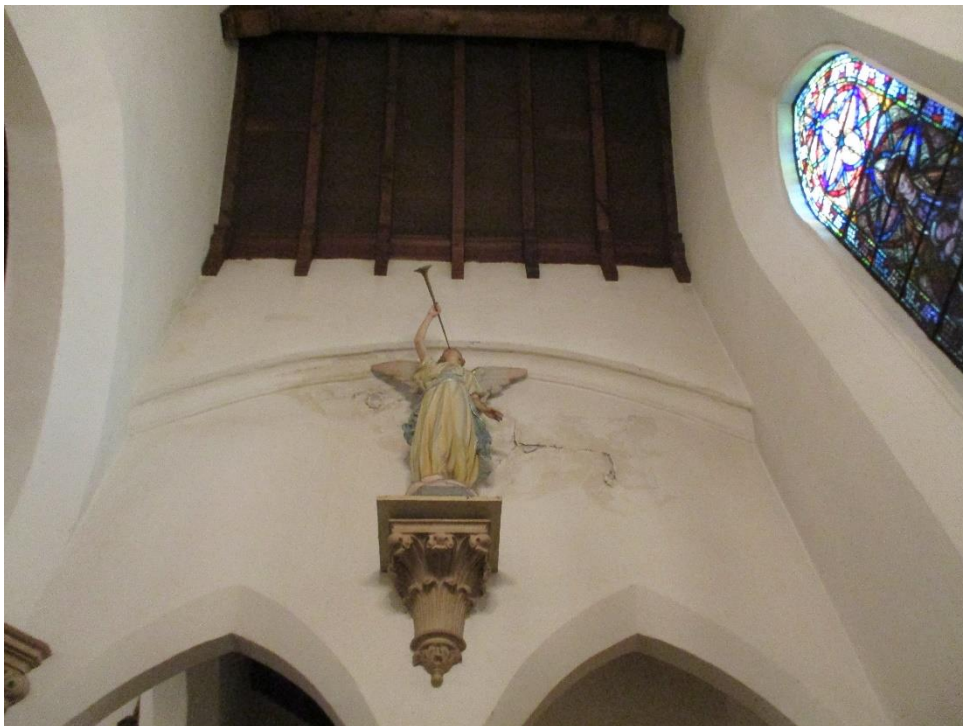
Photo 12

Water staining at east transept.

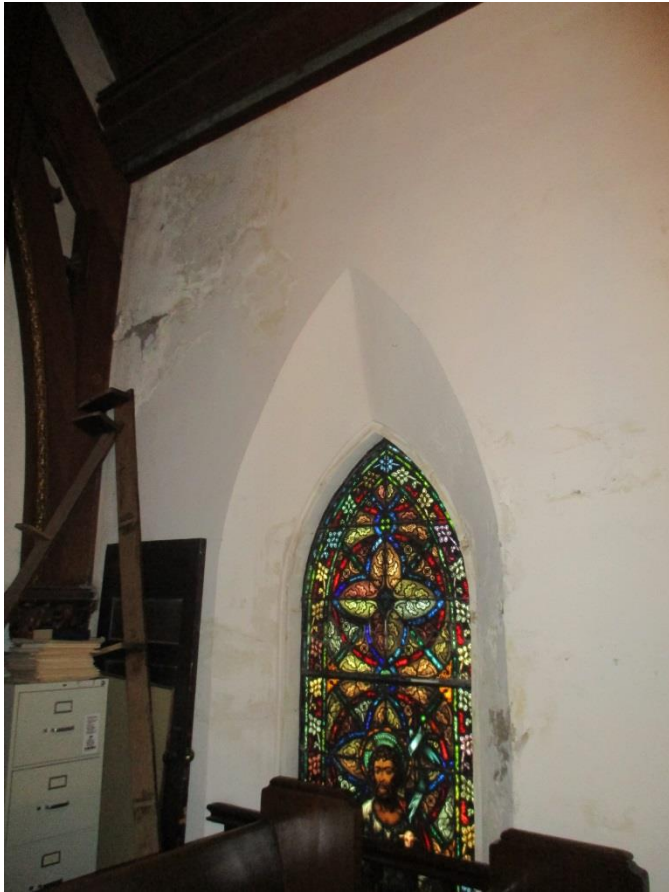
Photo 13

Water damage at balcony.

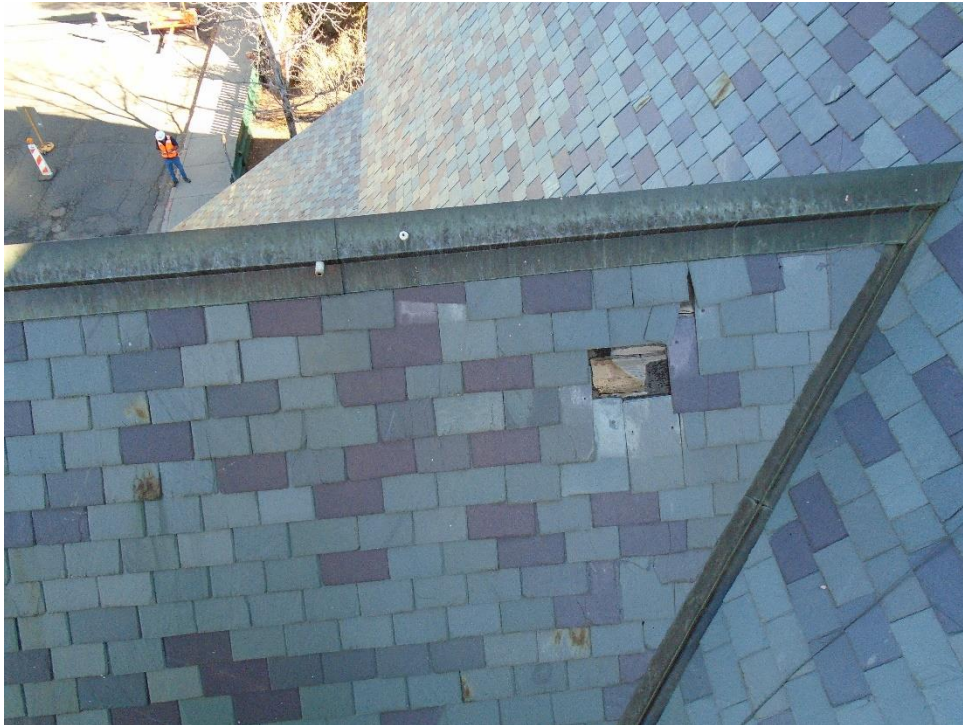
Photo 17

- At isolated locations, we observed missing/displaced roof tiles exposing the underlayment (Photos 17 and 18). In one location, the roof sheathing was visible (Photo 17).

Missing and dislodged tiles.

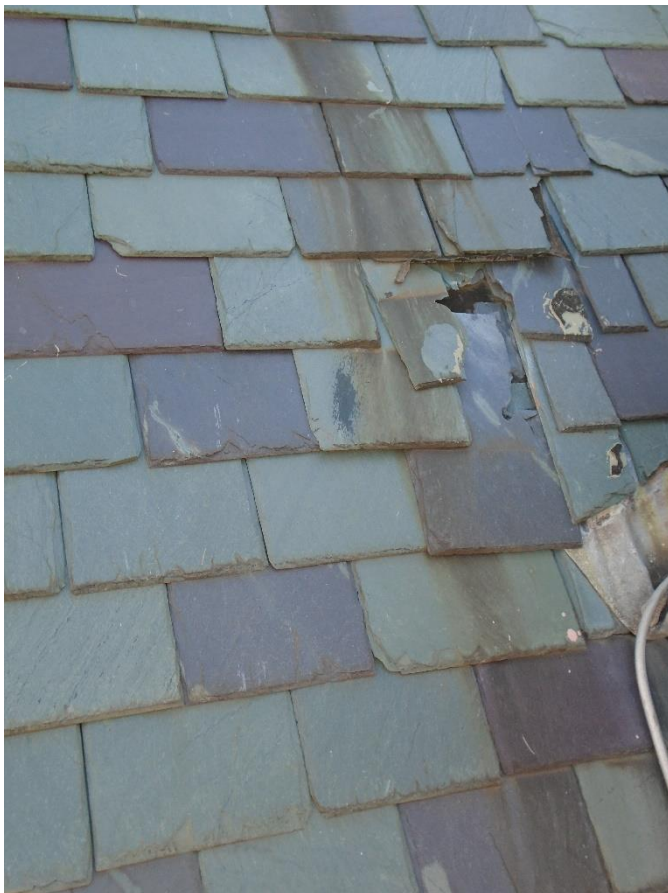
Photo 18

Missing, cracked, and dislodged tiles.

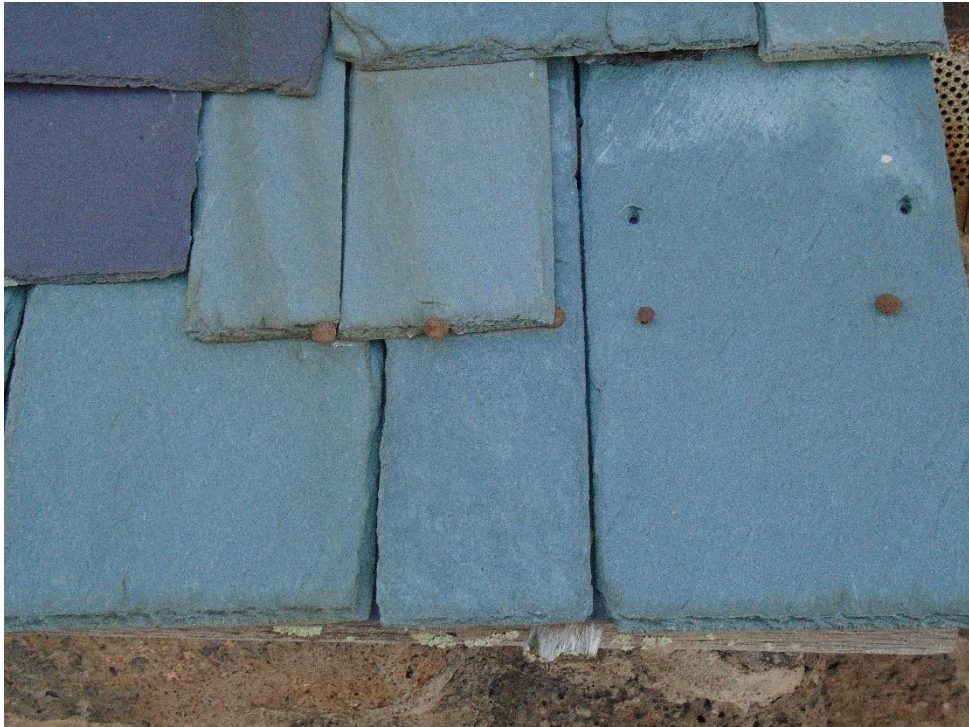
- Some repairs have installed tiles with improper or insufficient laps. Photo 19 shows an overly exposed joint lap due to the narrow width of the above tile (Photo 19).

Exposed nail heads and holes in tiles.

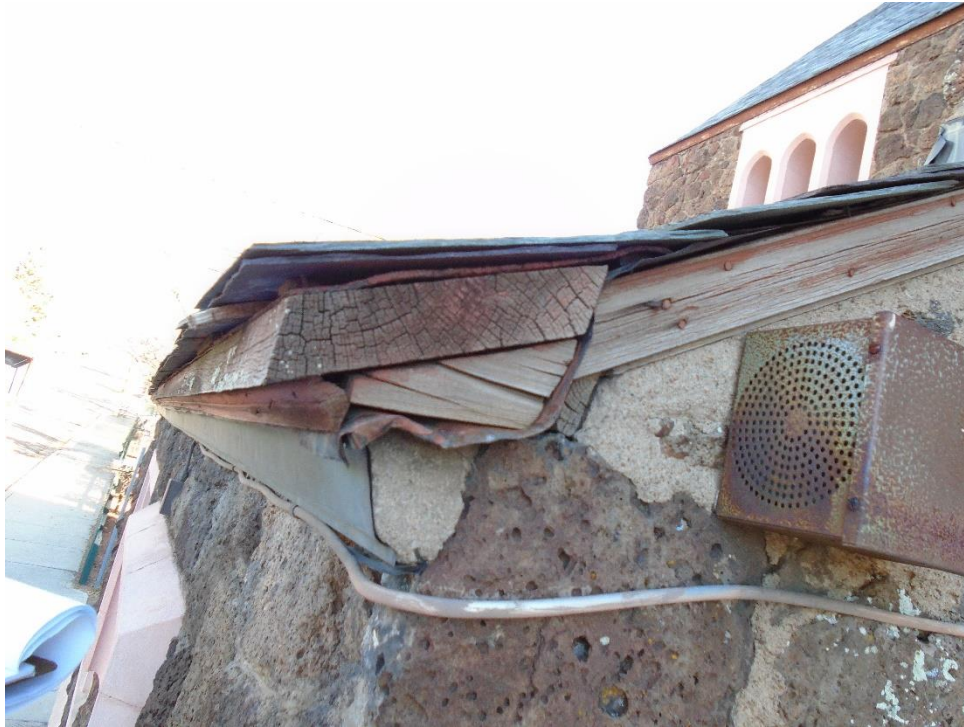
Photo 23

Typical rake condition with no sheet metal flashing.

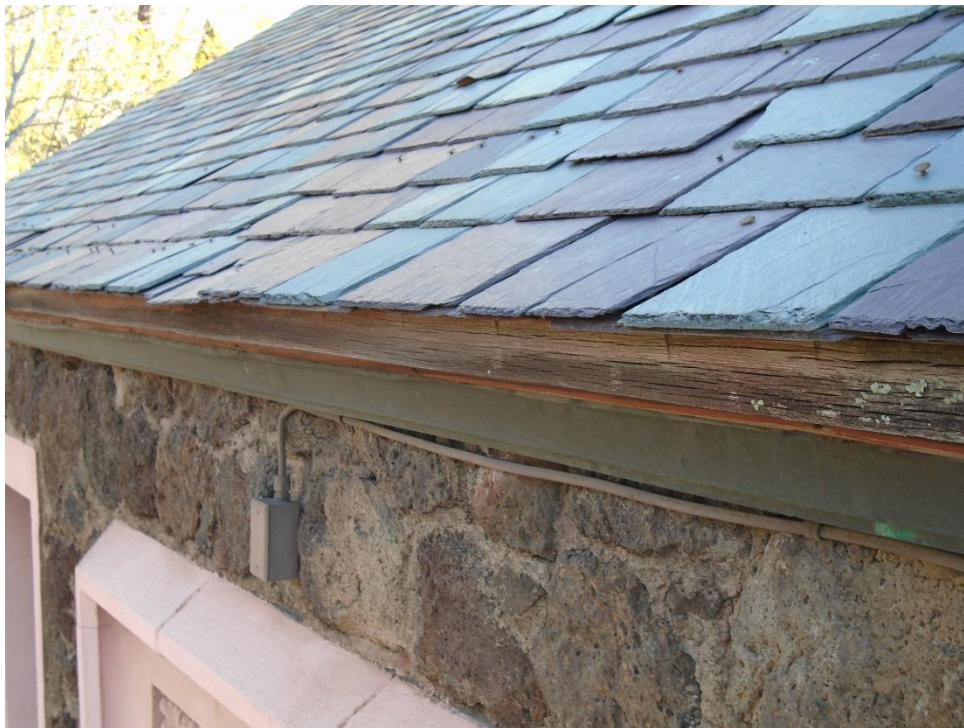
Photo 24

Typical roof edge condition with no sheet metal flashing.

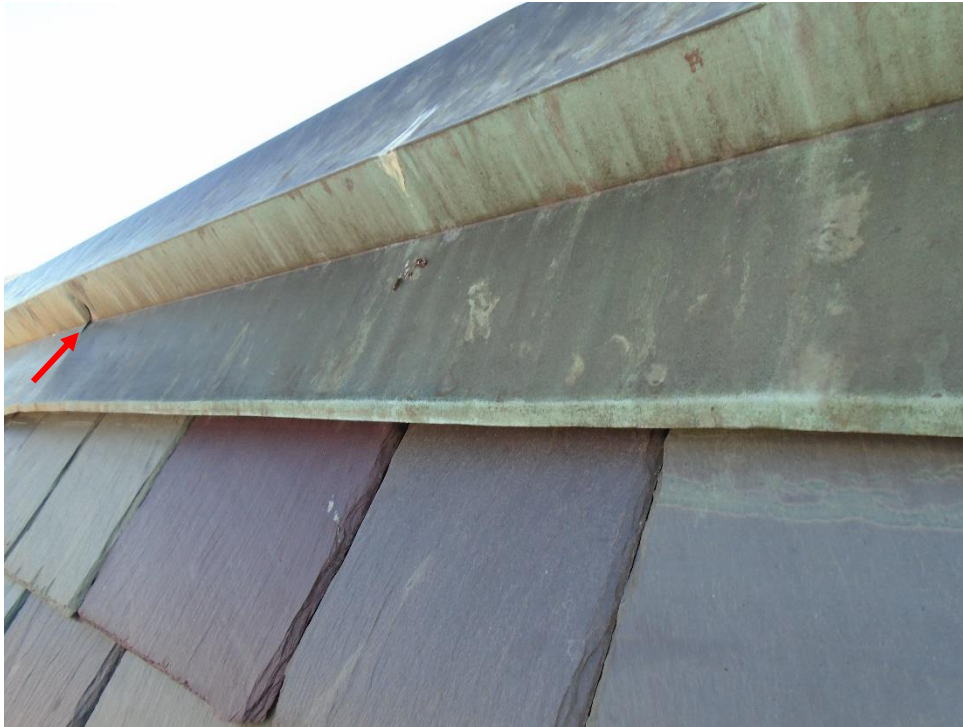
Photo 25

Buckling ridge cap section and split in the sheet metal (shown with arrow).

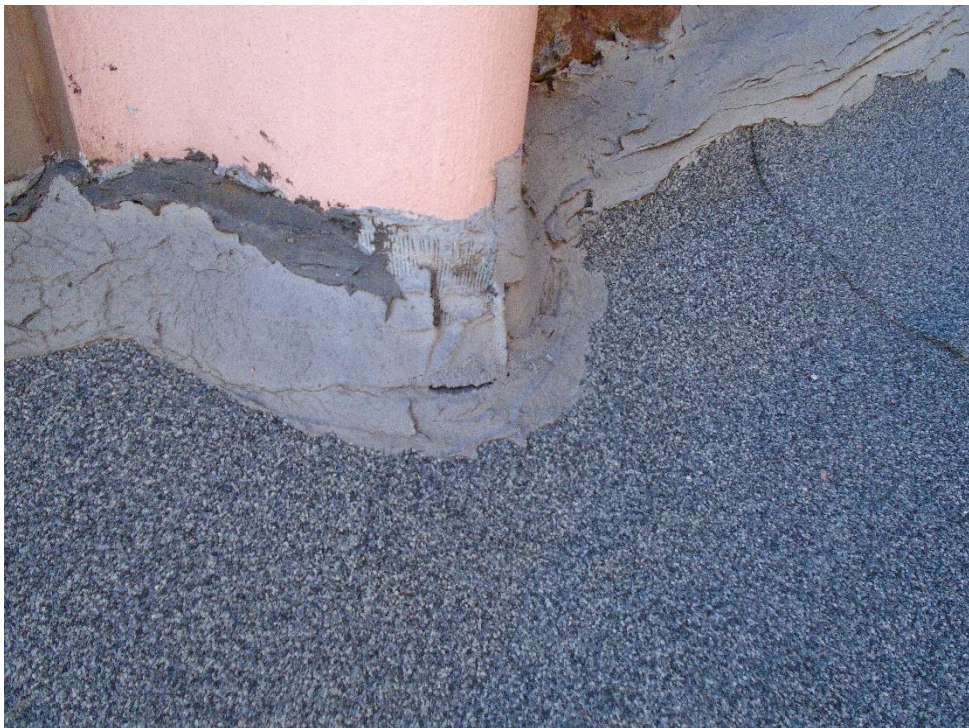
Photo 46

- In isolated locations, there were cracks in the liquid flashing (Photo 46), some in areas that potentially correspond to staining seen on the interior ceiling and walls.

Crack in the roof membrane counterflashing.

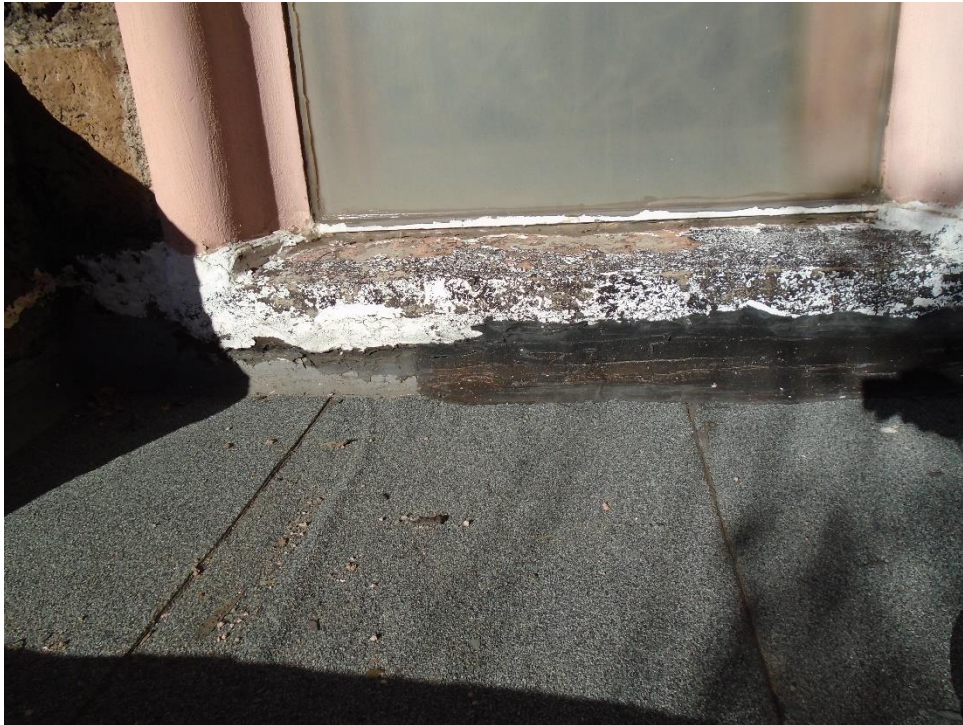
Photo 47

Roof membrane terminates at the precast window sill which is coated with peeling liquid flashing.

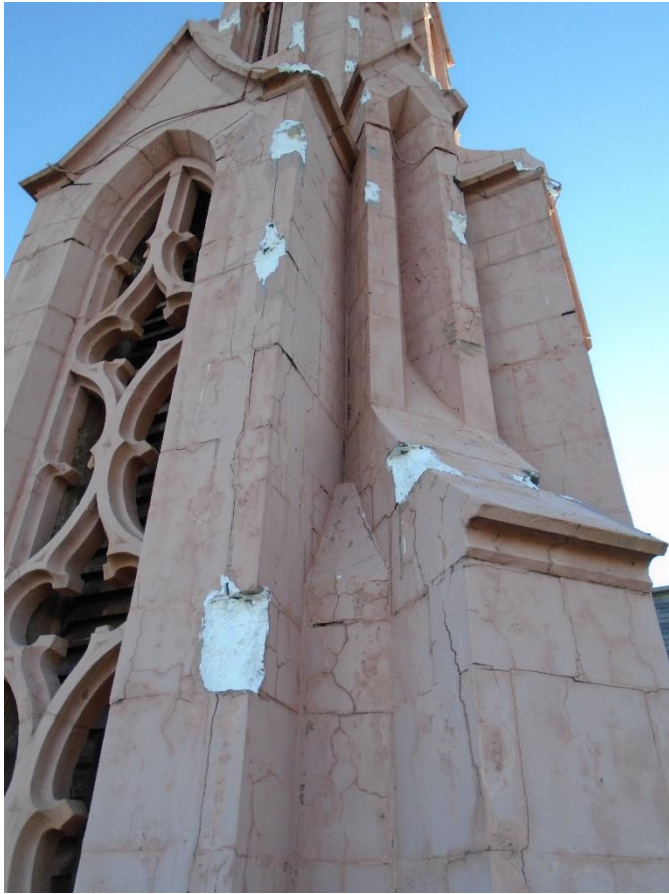
Photo 51

Cracking and spalls at the tower.

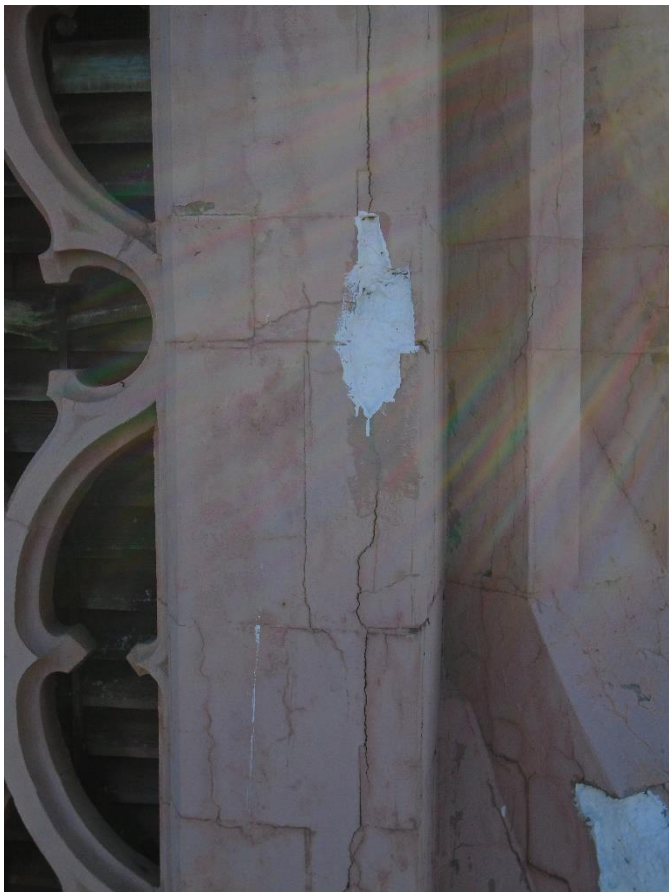
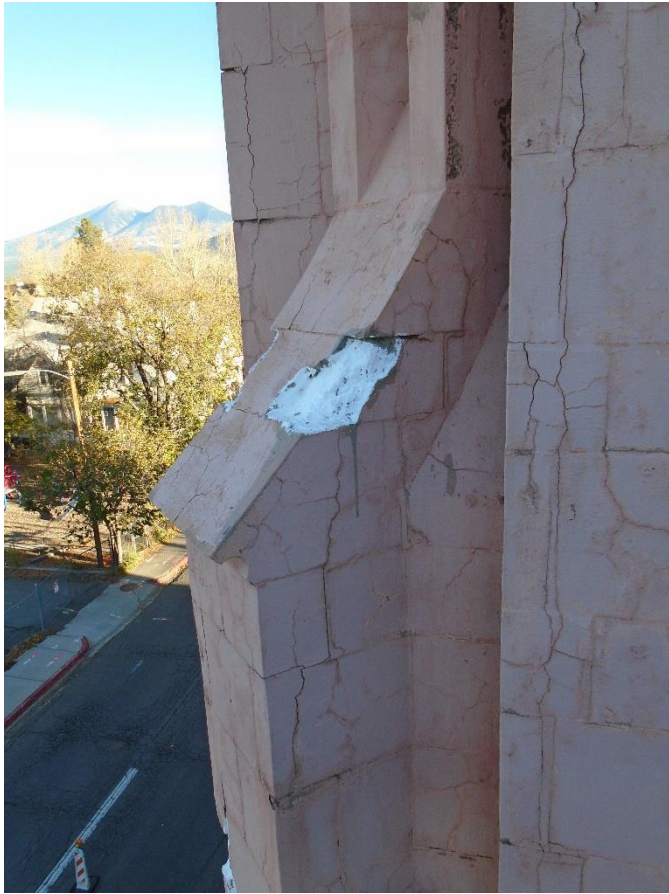
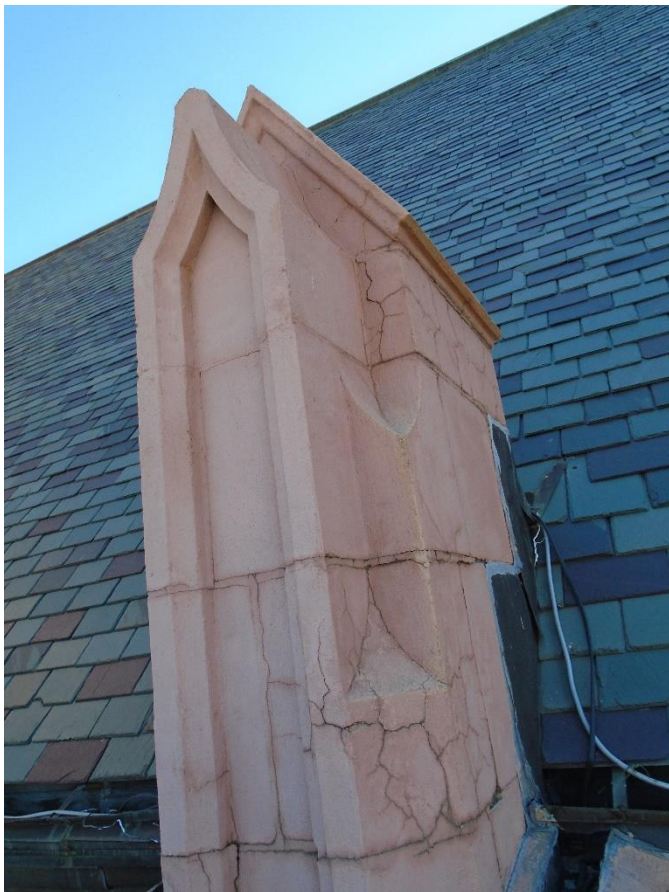
- On the tower and buttress precast blocks, we observed vertical, horizontal and map cracking (Photos 51 – 54). There are open cracks that range from 0.012 in. to greater than 0.040 in. wide (Photos 55 and 56). Approximately 75% or more of the tower blocks, and 50% of the buttress blocks, contain cracks or spalls.

Vertical, horizontal, and map cracking.

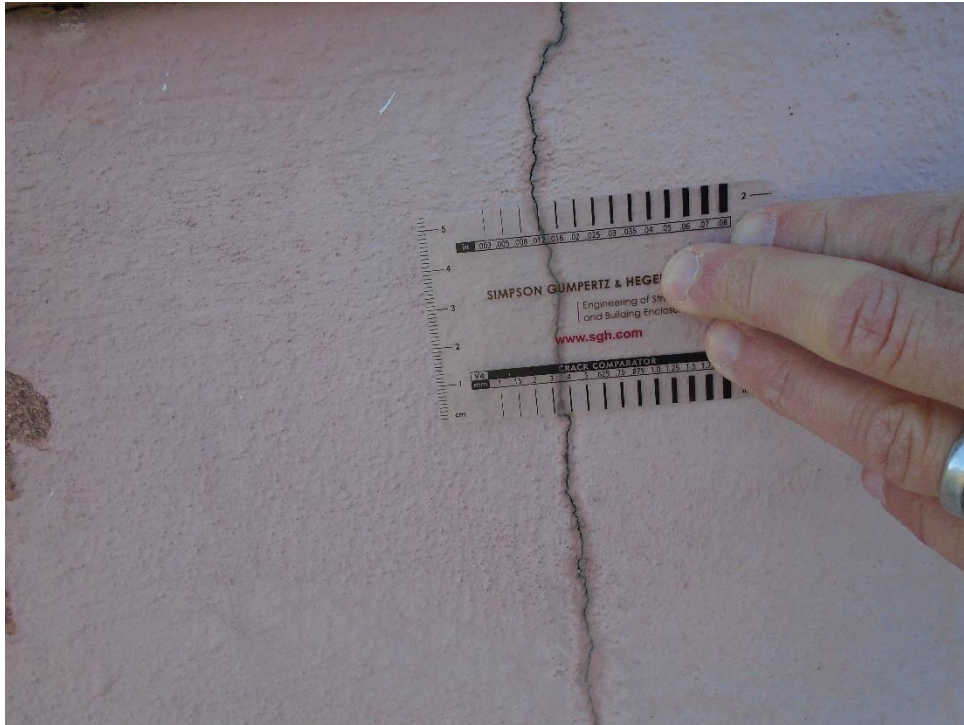
Photo 55
Typical crack.

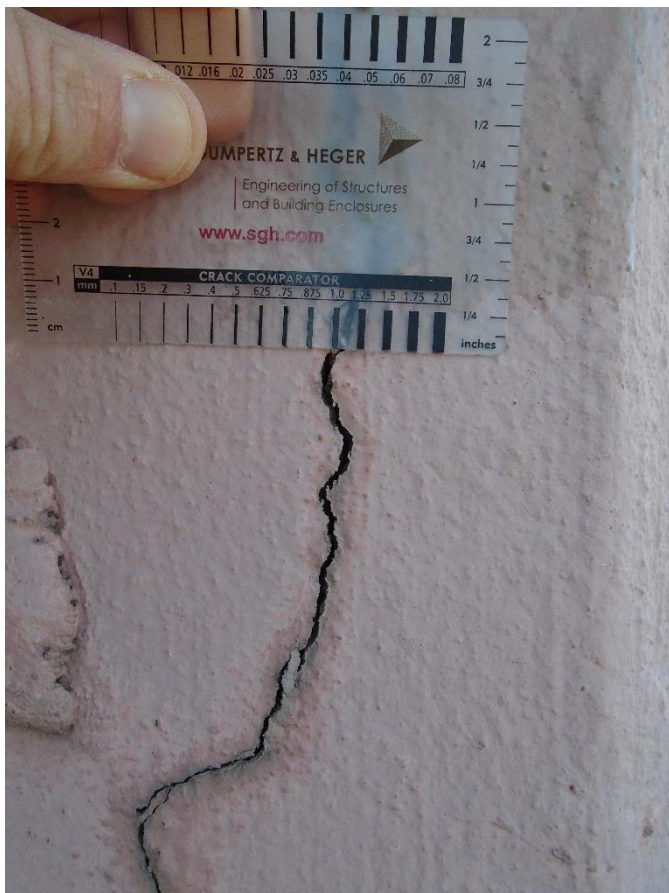
Photo 56
Open crack.

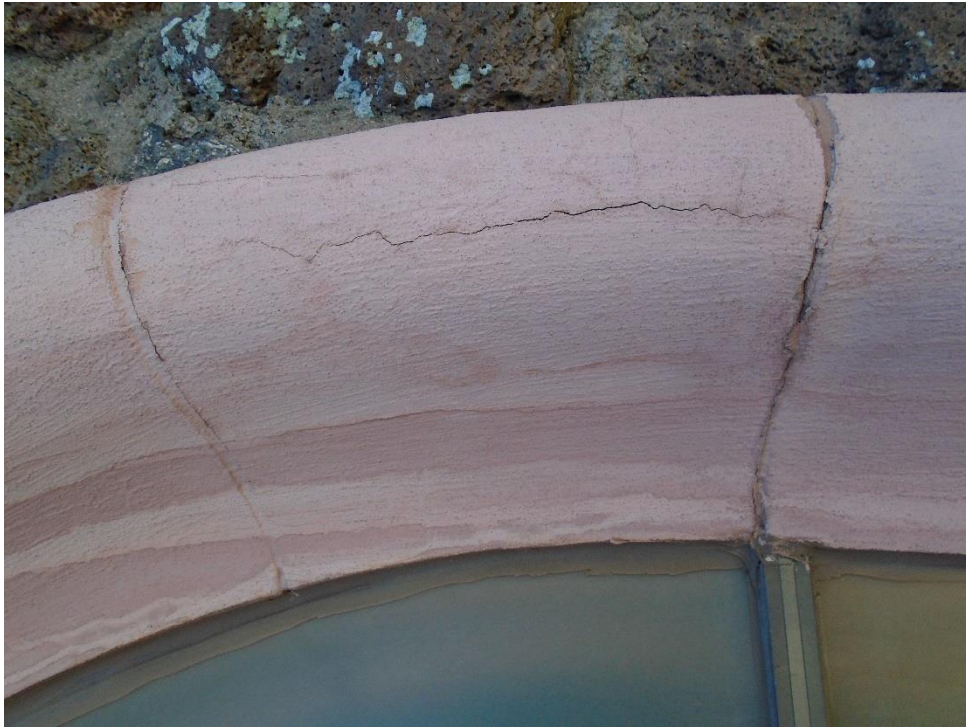
Photo 57

- In general, the cracking found at blocks lower on the building such as at window surrounds and the water table were not as frequent or severe. Many of the cracks were less than .012 in. wide (Photos 57 and 58). The number of blocks that are cracked or spalled may be as low as 5%.

Crack at window surround.

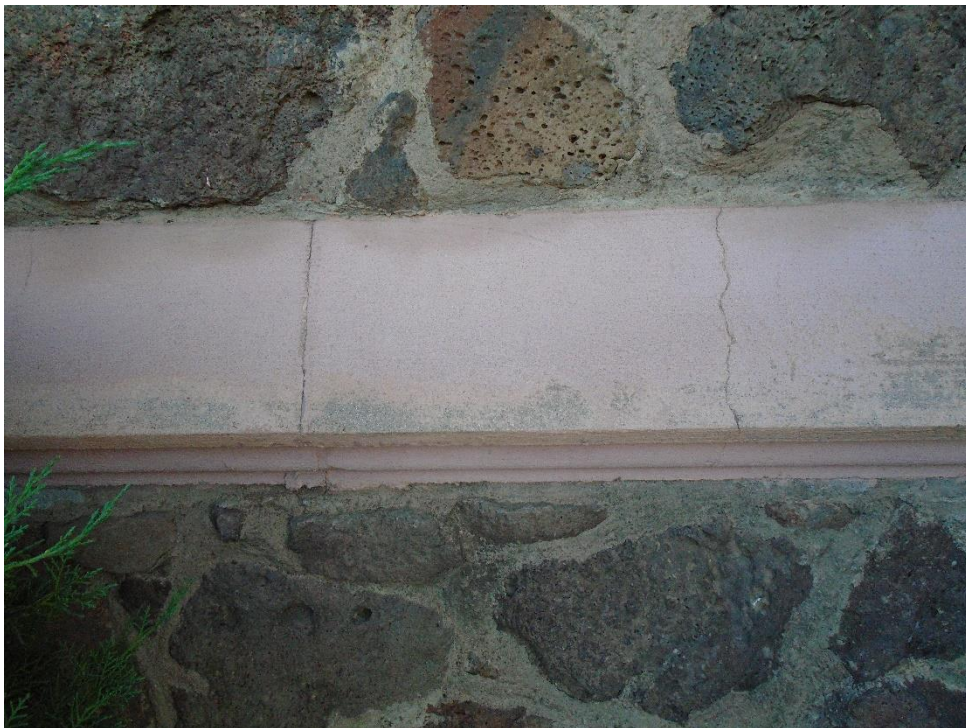
Photo 58

Crack at water table.

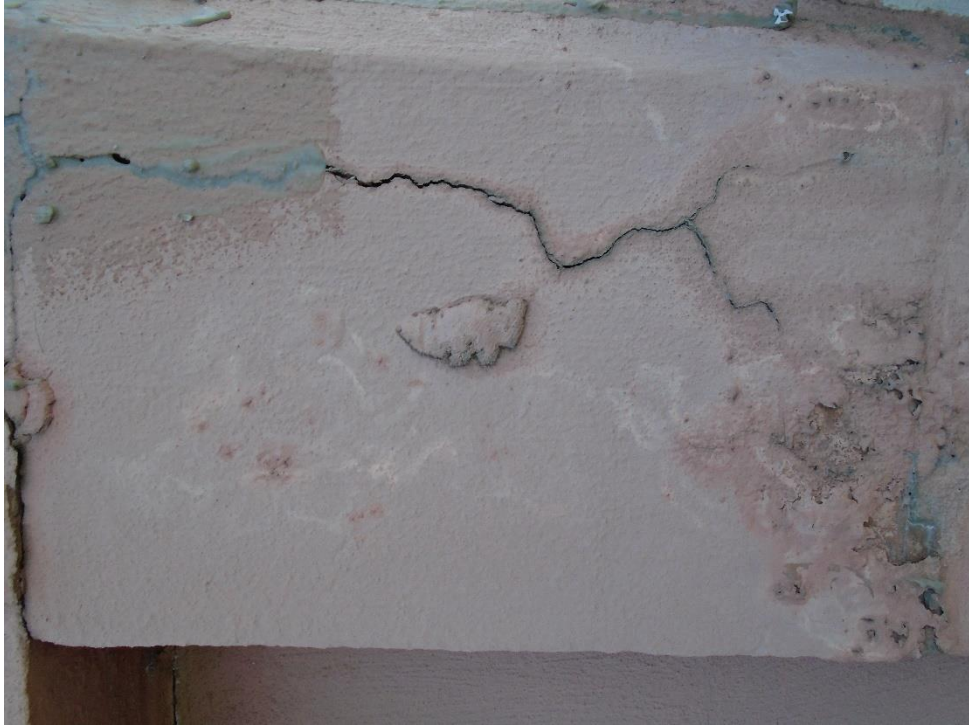
Photo 59

Partial epoxy crack repair.

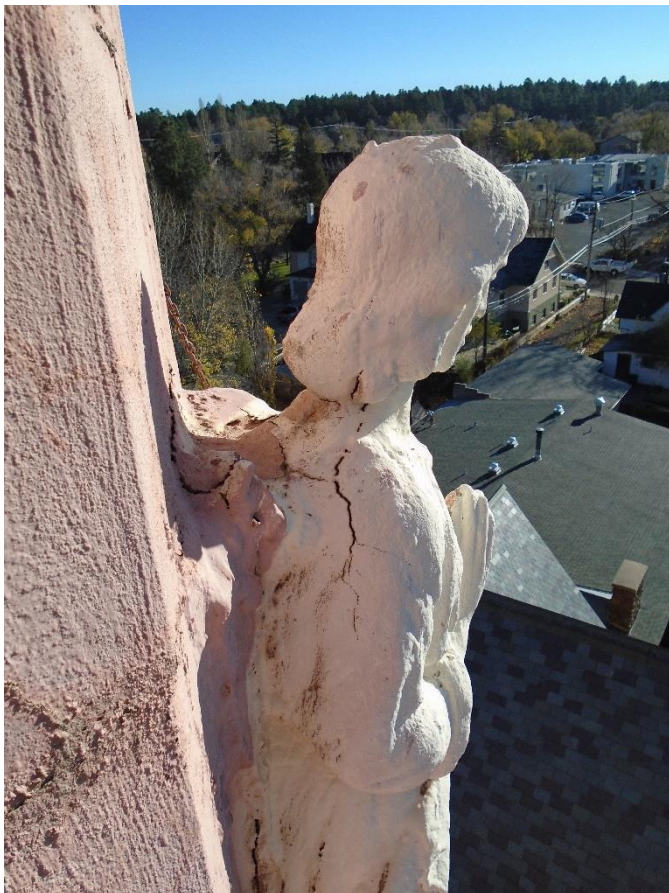
Photo 60

Vertical open crack in statue.

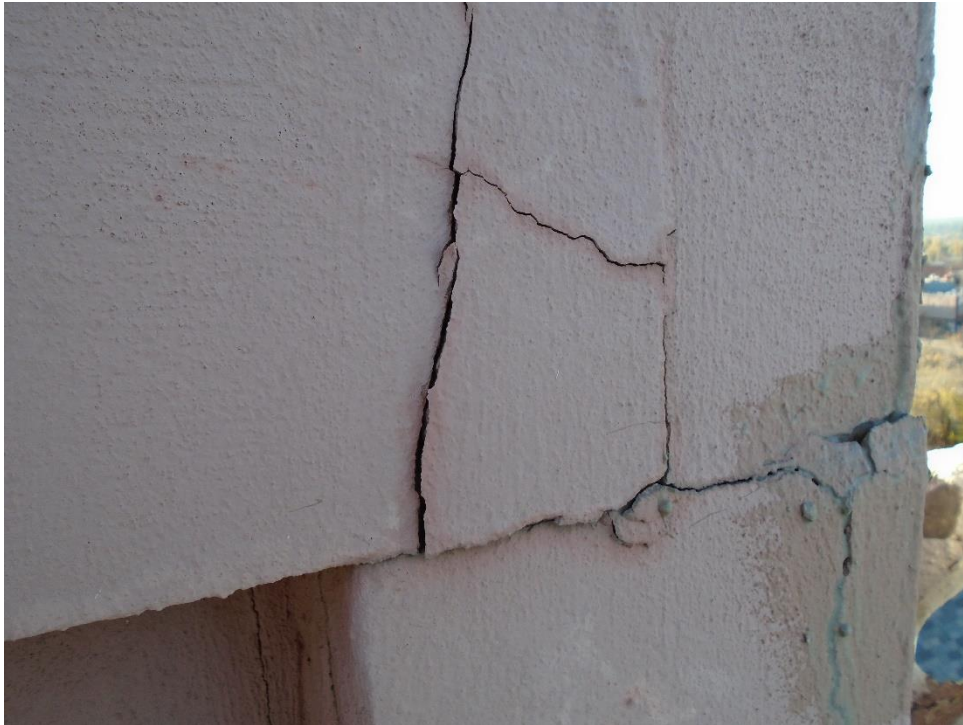
Photo 61

- In the vicinity of vertical, horizontal, and map cracks, we found isolated incipient spalls on the precast surface (Photos 61 and 62). The spalls were located within the field of blocks and at corners.

Incipient spall formed
between cracks.

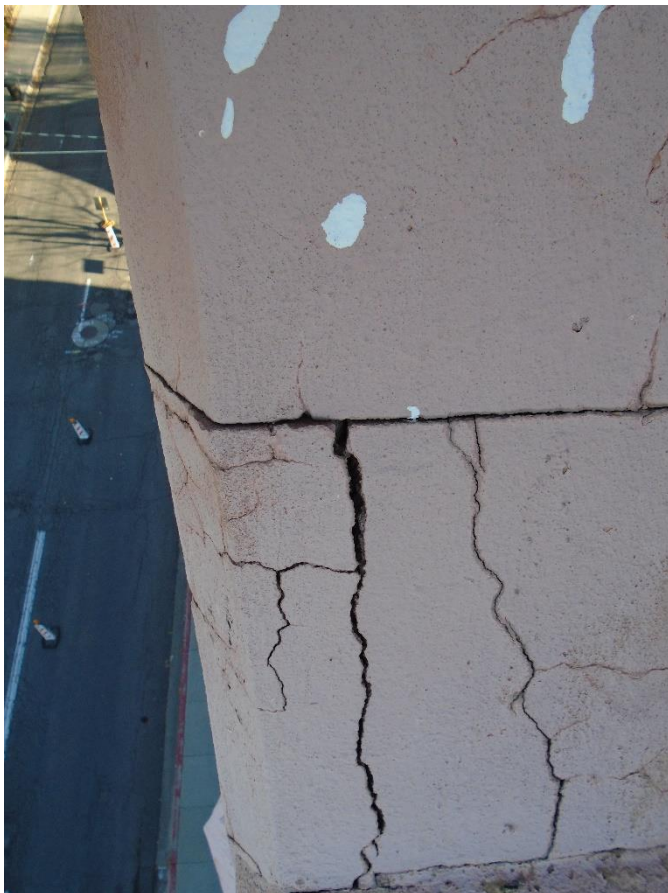
Photo 62

Incipient spall formed
between cracks.

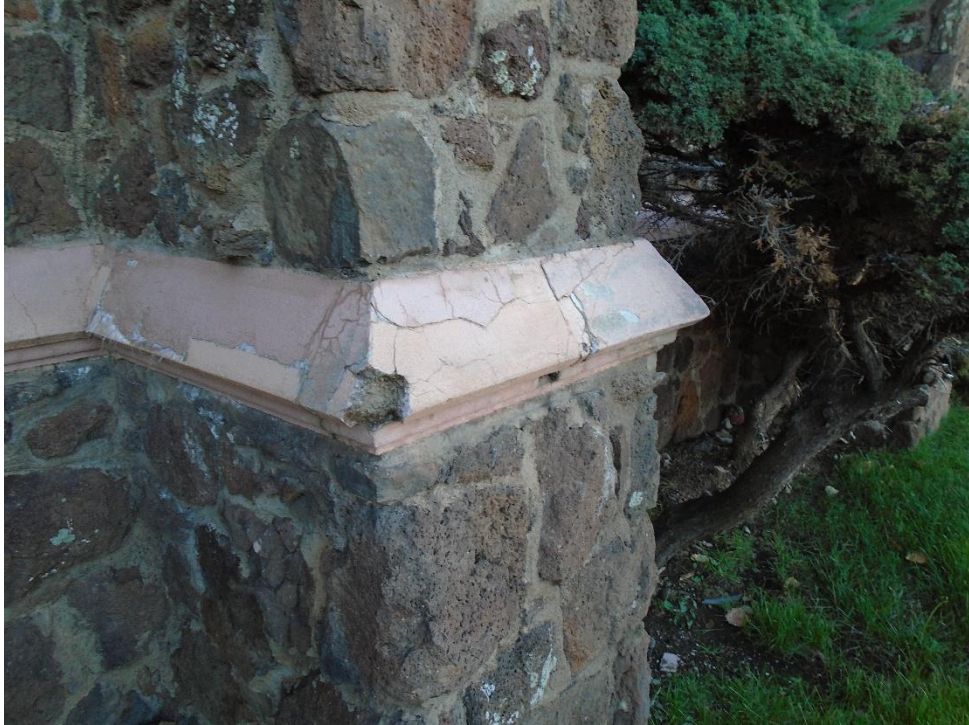
Photo 63

Removed spall at water table.
