FACADE
REHABILITATION
PRE-DESIGN
INVESTIGATION AND
CONDITIONS
ASSESSMENT

Nativity of the Blessed
Virgin Mary Chapel
Flagstaff, Arizona
1 May 2017

SGH Project 167283

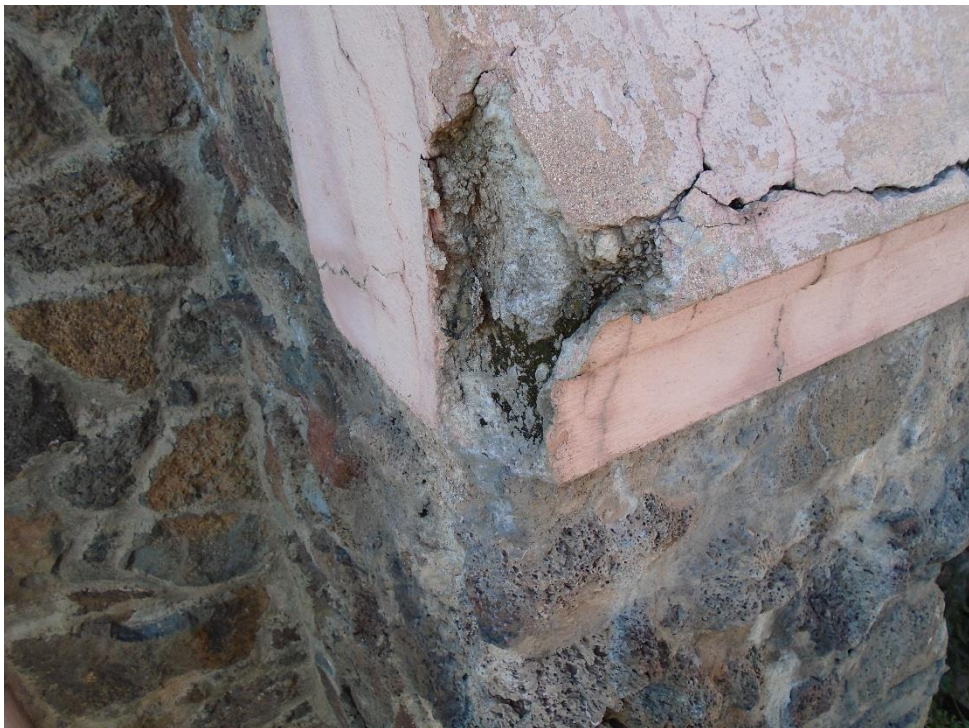
Photo 64

Removed spall at buttress water table.

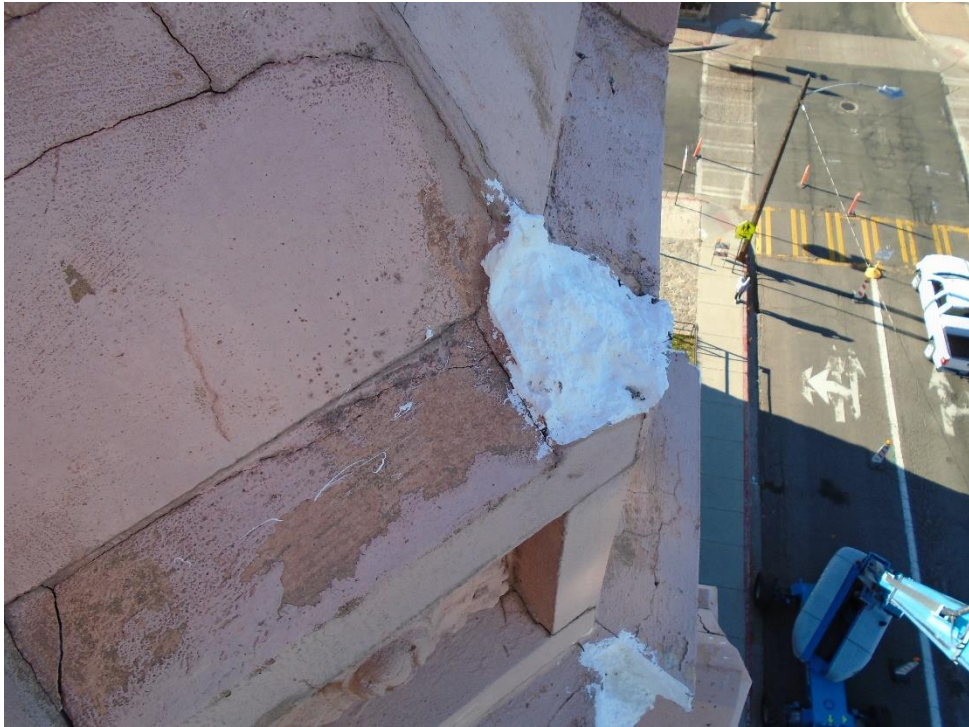
Photo 65

Typical painted over spill.

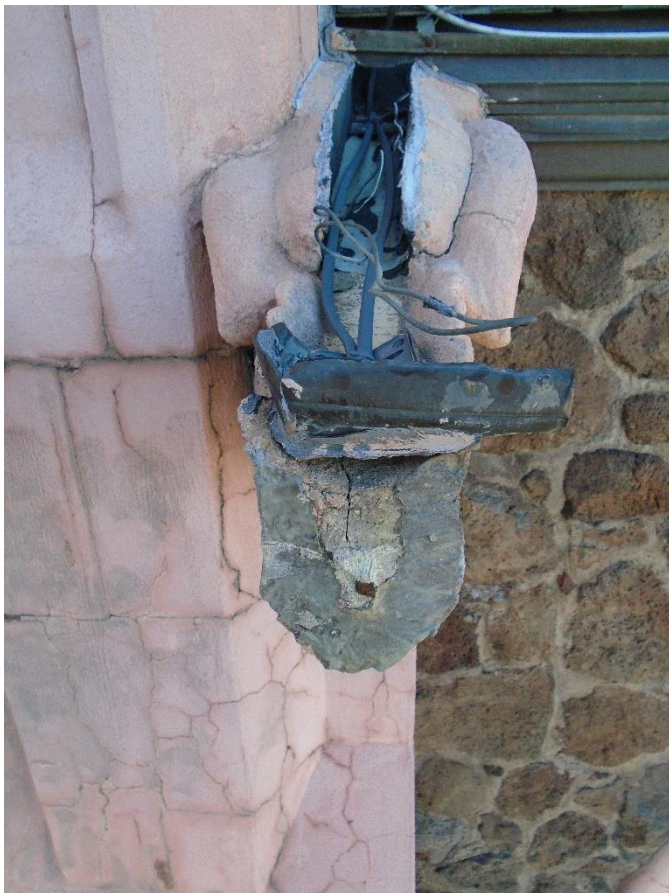
Photo 66

Missing gargoyle head.

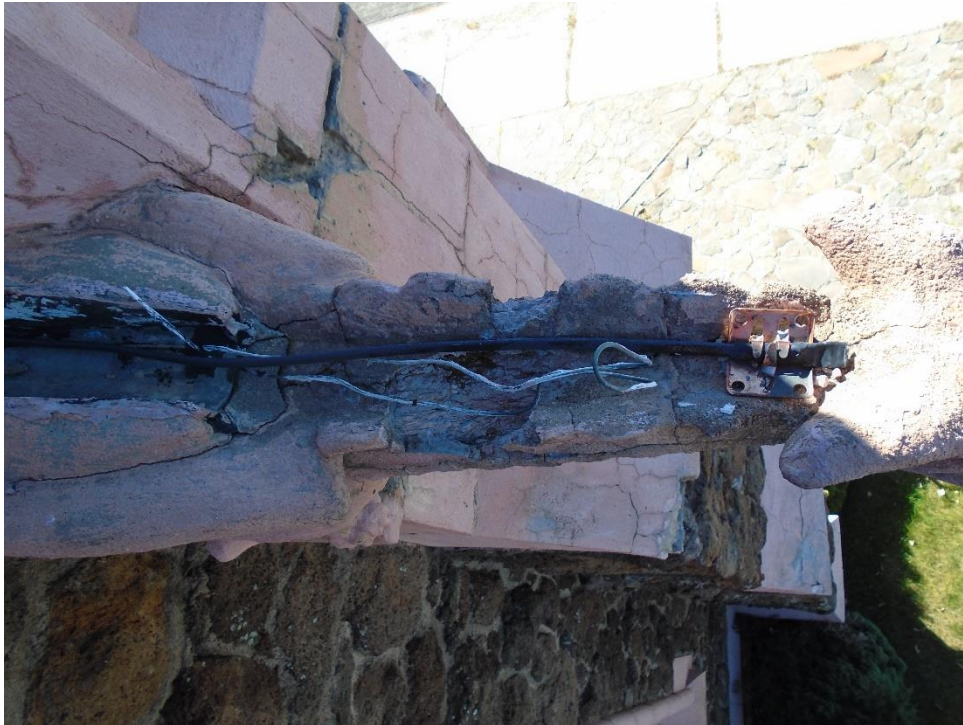
Photo 67

Cracks in neck of gargoyle.

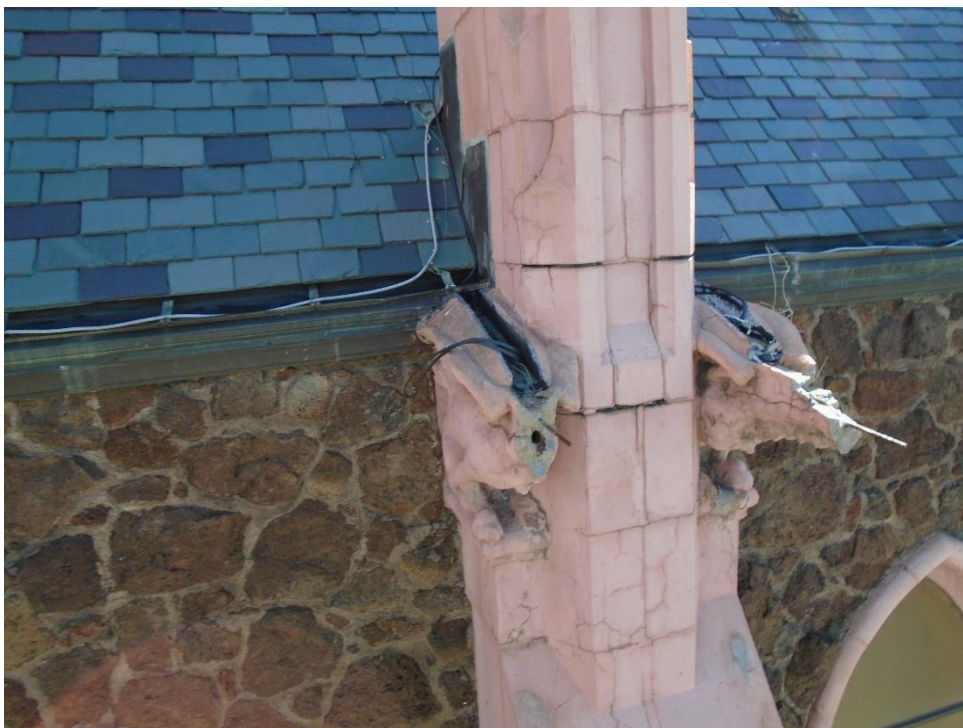
Photo 68

Exposed corroded rebar through gargoyles.

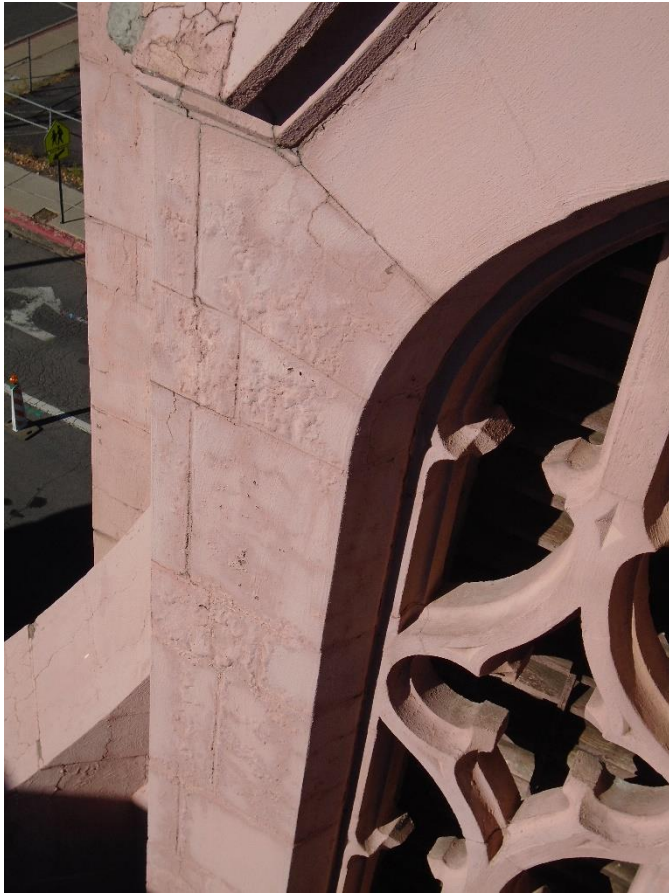
Photo 69

Bubbling and peeling paint coating.

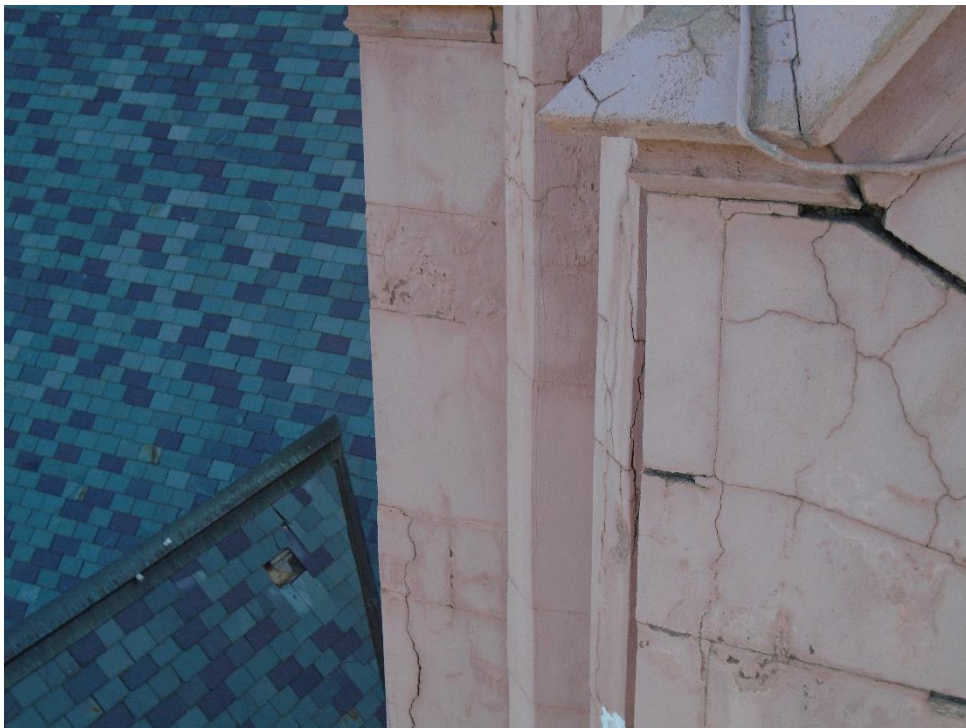
Photo 74

Deteriorated mortar joints.

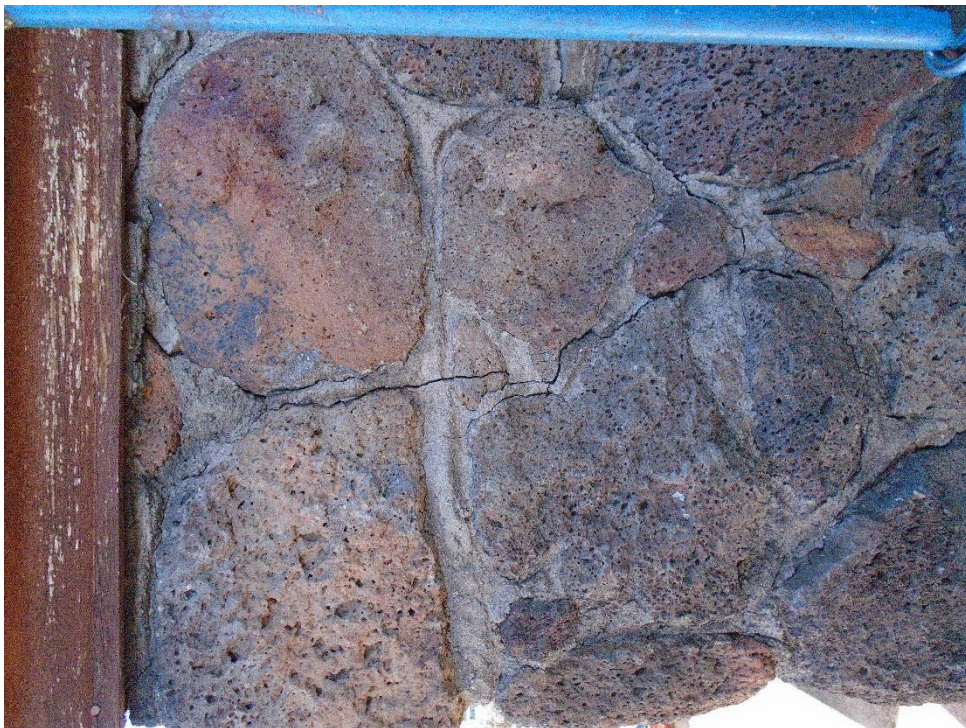
Photo 78
Isolated crack in volcanic rock.

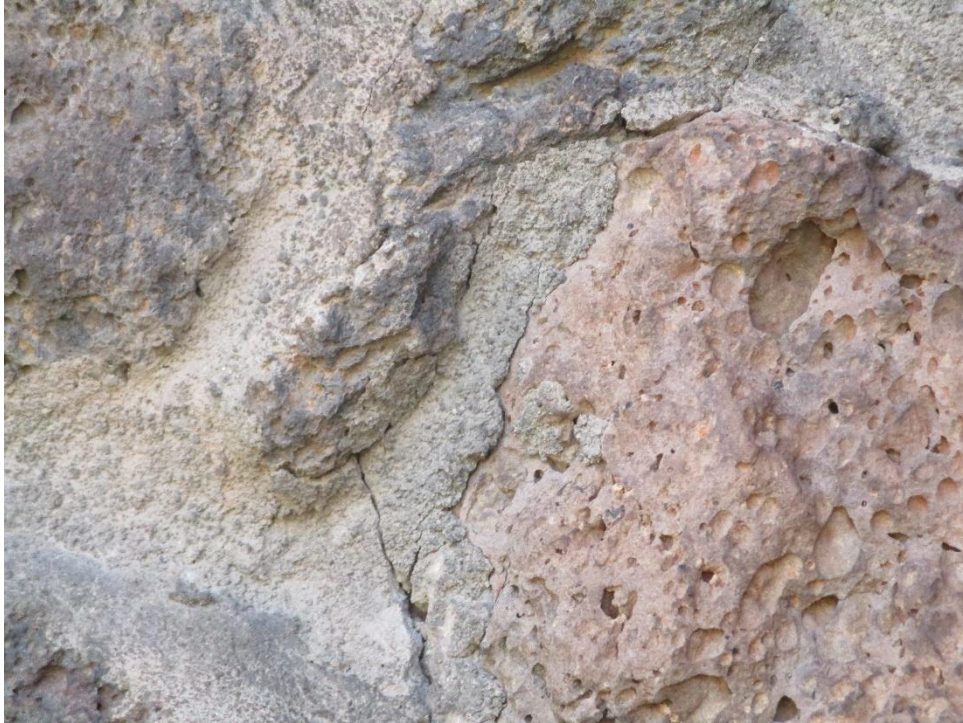
Photo 79

Cracked and deteriorated mortar joints.

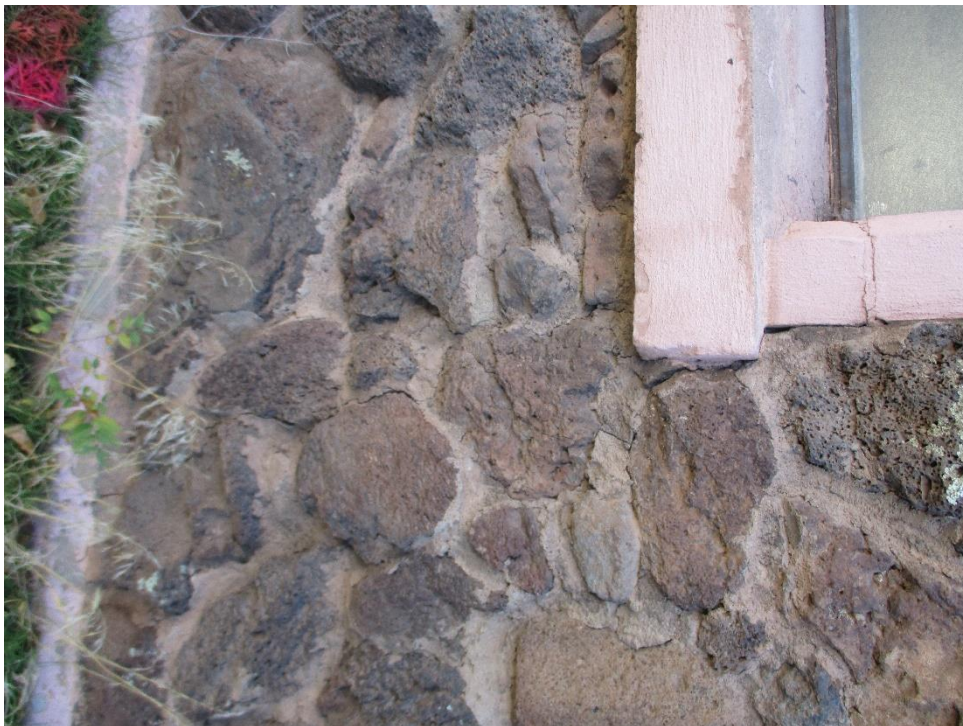
Photo 80

Over-pointed mortar joints.

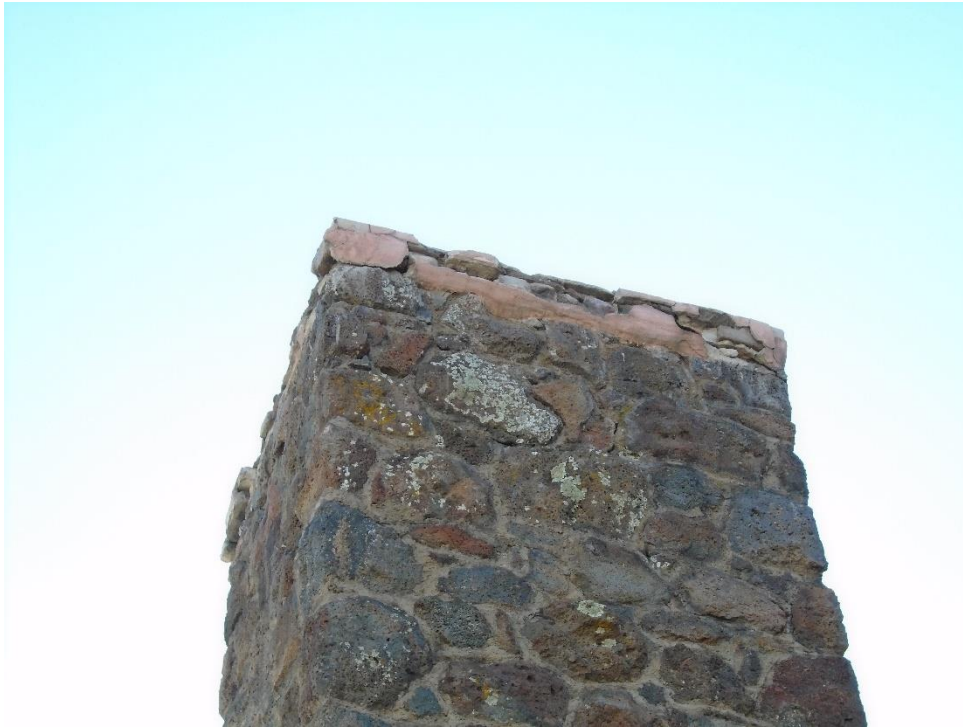
Photo 81

Volcanic rock and cement plaster walls: These walls are generally in good condition and need routine maintenance. However, at the top of the chimney there is some loose masonry and mortar that should be repaired, as it is a falling hazard.

Loose and deteriorated coping at top of chimney.

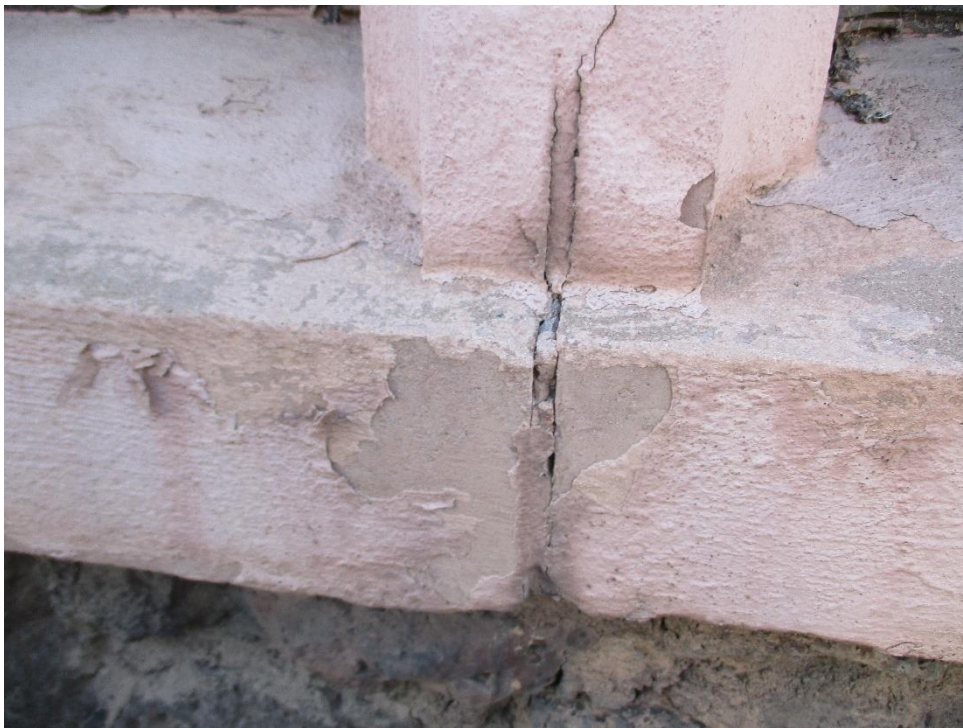
Photo 82

Deteriorated cement plaster parge coat.

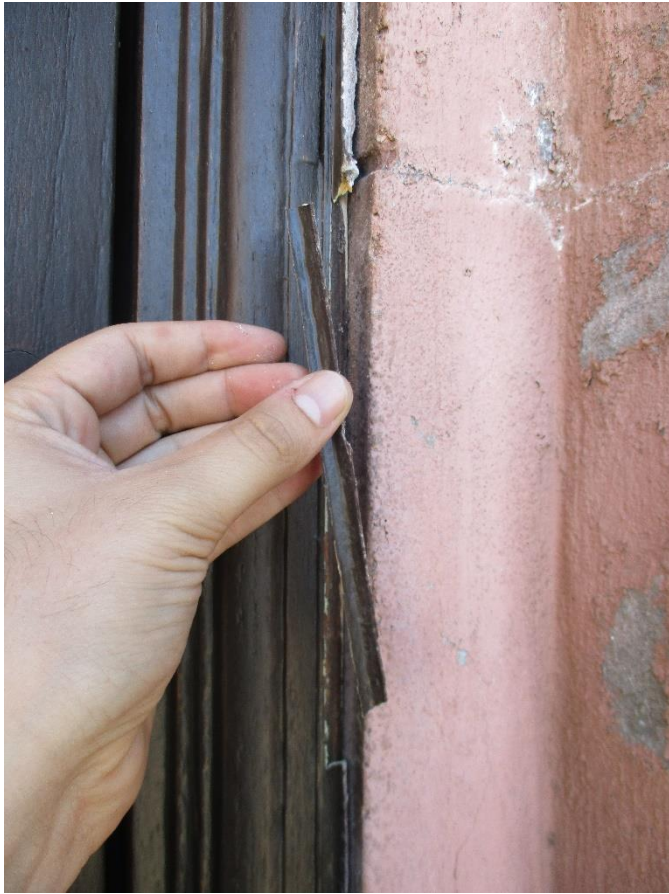
Photo 91

Broken-missing trim.

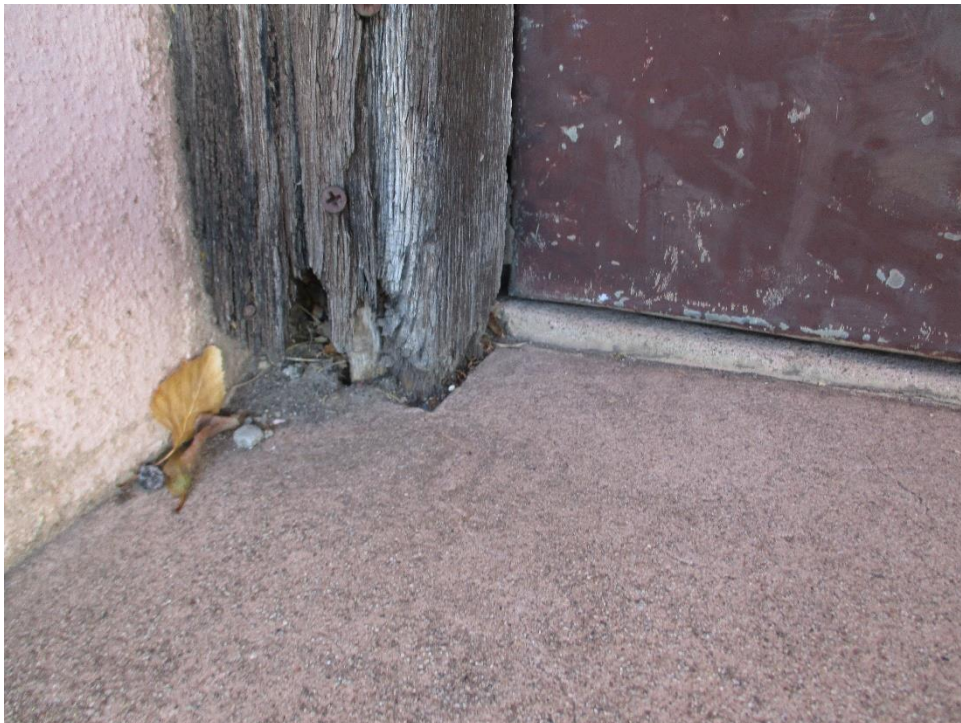
Photo 92

Rotted wood door frame.

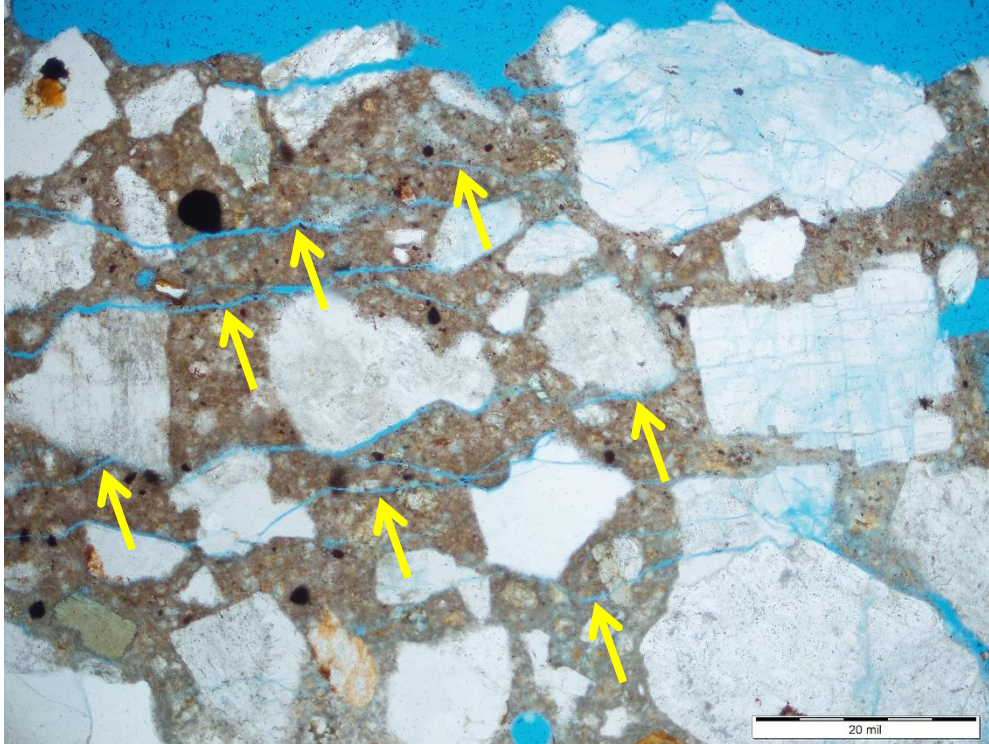
Photo 12

Photomicrograph of the ultrathin section of Sample 2, depicting the outermost zone of the second layer of mortar (the first layer of mortar is missing in this area). Note the tightly spaced, parallel microcracks (yellow arrows).

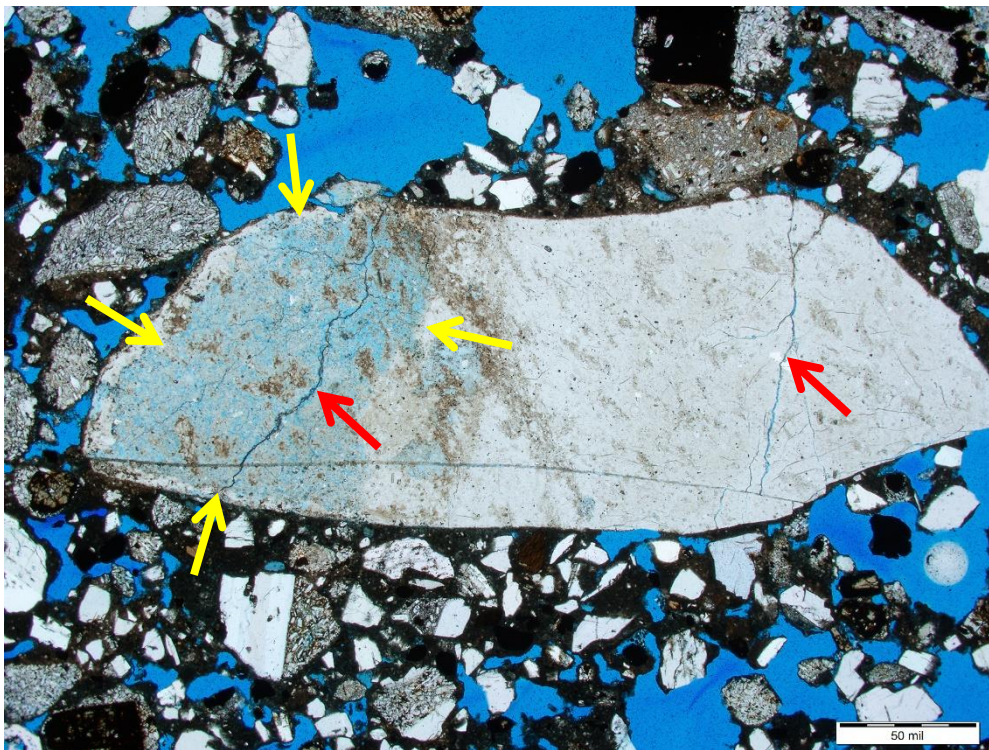
Photo 17

Photomicrograph of the ultrathin section of Sample 3, depicting a coarse aggregate particle of rhyolite that exhibits signs of ASR, such as a high density of internal cracks (red arrows) and localized high internal porosity (indicated by the stronger saturation of blue-dyed epoxy in the area bounded by yellow arrows).

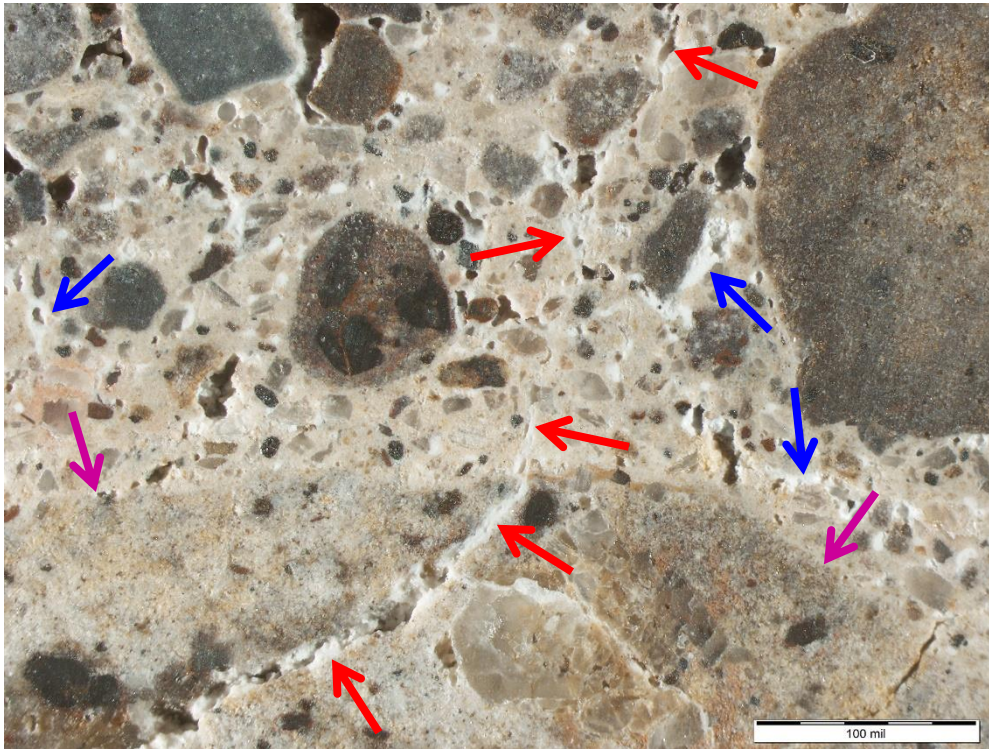
Photo 21

Detail of the polished section of Sample 5, depicting cracks filled with white colored deposits (red arrows) that extend from a coarse aggregate particle of dacite (lower third of image, bounded by purple arrows) into the surrounding paste structure. Also note the entrapped air voids that are partially to completely filled with white deposits (blue arrows).
