FACADE
REHABILITATION
PRE-DESIGN
INVESTIGATION AND
CONDITIONS
ASSESSMENT

Nativity of the Blessed
Virgin Mary Chapel
Flagstaff, Arizona
1 May 2017

SGH Project 167283

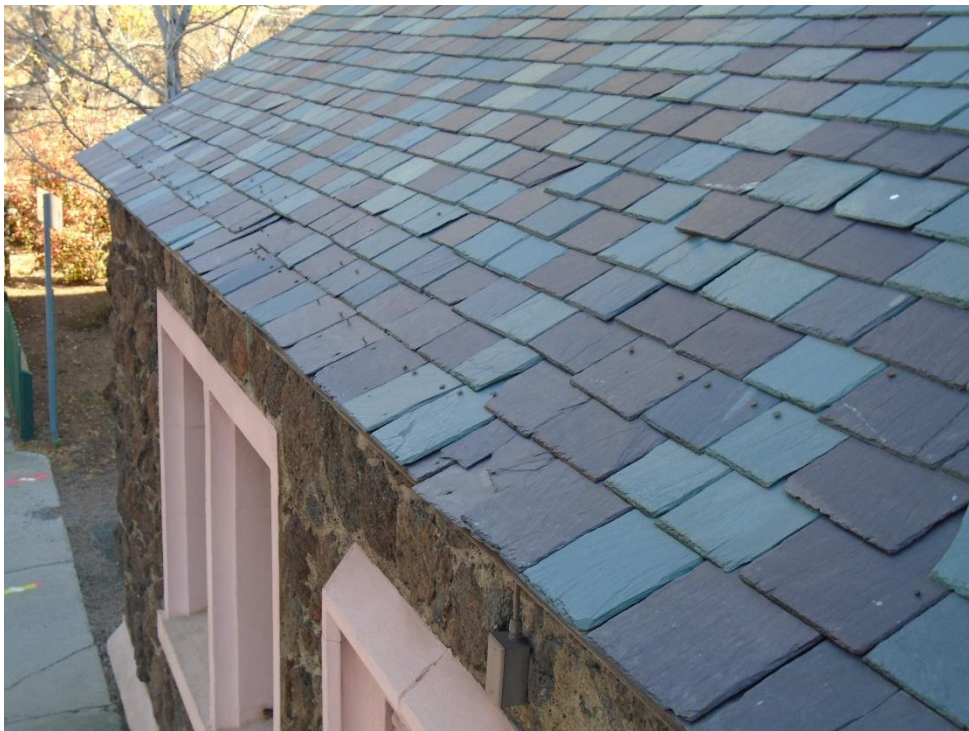
- Vestry rooms appended to the rear of the chapel are covered by steep-slope shed roofs that terminate at the stone walls of the main chapel. The lower roofs are finished with slate tiles (on the west elevation) and asphalt shingles (east elevation) (Photos 32 and 33).

Photo 32
Steep-slope roof at rear of church.

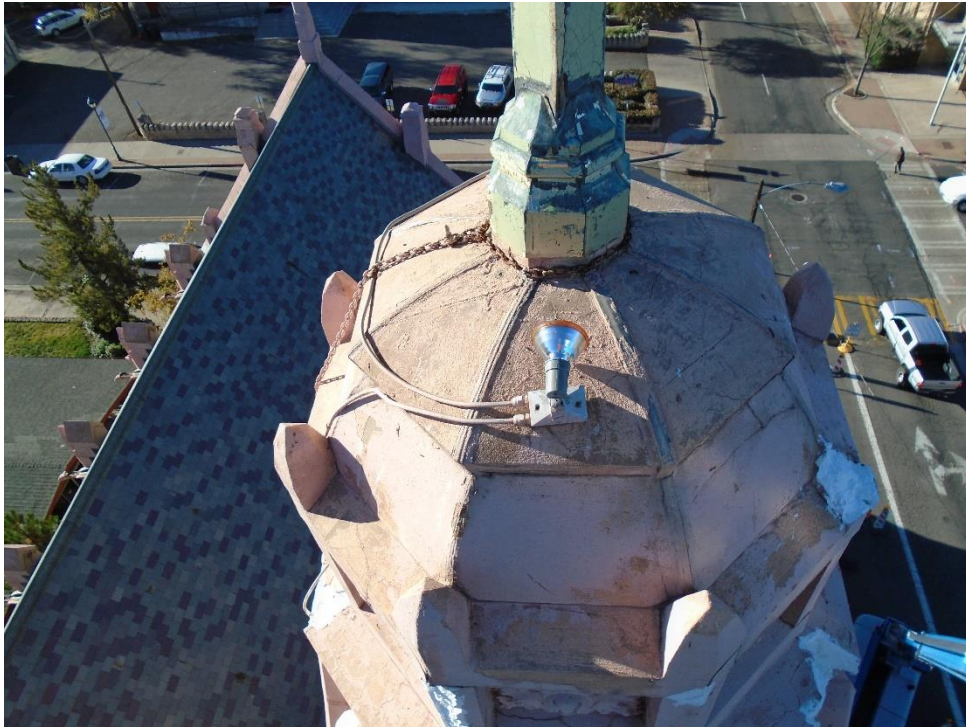
Photo 76

Lead joint covers (painted over) set in sealant or mortar.
