FACADE
REHABILITATION
PRE-DESIGN
INVESTIGATION AND
CONDITIONS
ASSESSMENT

Nativity of the Blessed
Virgin Mary Chapel
Flagstaff, Arizona
1 May 2017

SGH Project 167283

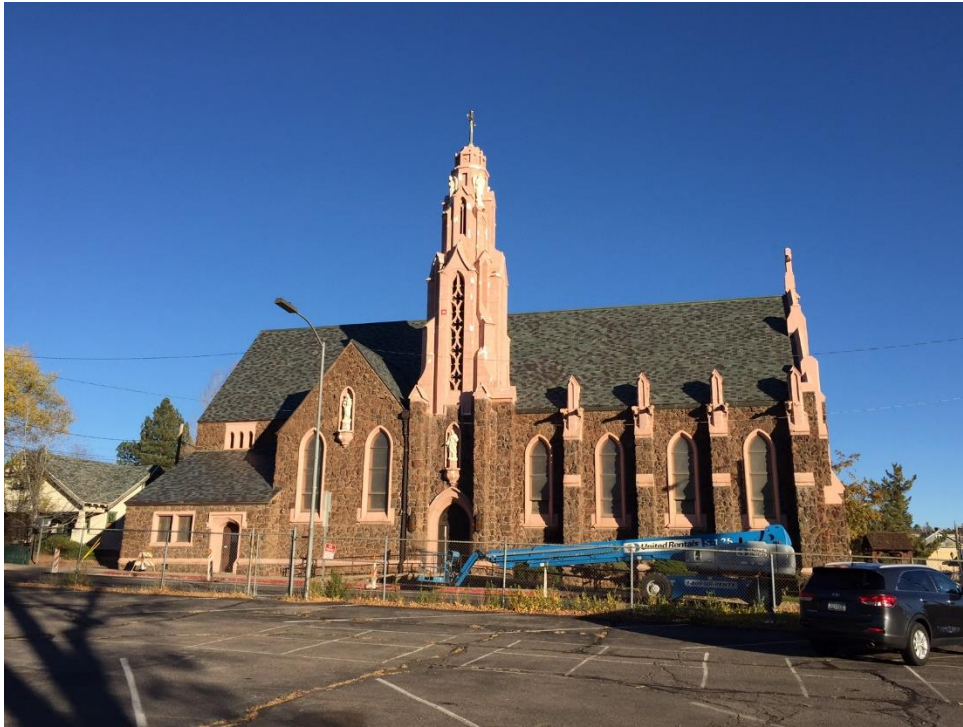
Photo 1

Completed in 1930, the Gothic style Nativity of the Blessed Virgin Mary Chapel (chapel) adopts cruciform plan with a large, asymmetrical buttressed tower topped by a cupola (Photos 1 and 2). The building walls are cast-in-place concrete finished with local coursed rubble volcanic rock and precast concrete cladding and ornamental features. A high-pitched gable roof covered with slate shingles surmounts the volcanic stone walls. Stained glass lancet windows punctuate the east and west walls of the nave and transept. The south elevation features an arched stained glass tracery window and wooden main entry doors framed by a precast concrete arch with inset branch tracery at the upper border (Photo 3). Other window openings include arched and flat-arched, leaded, casement windows with amber glass. Most of the window openings have been covered on the exterior with aluminum framed, plexi-glass protective glazing.

West elevation view.

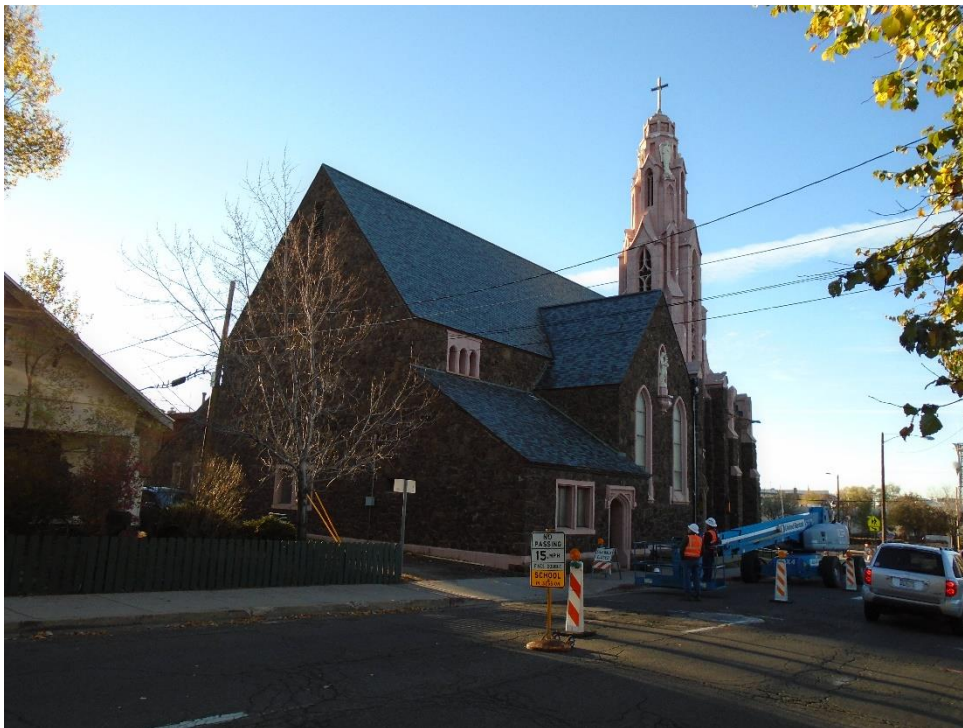
Photo 2

View from the northwest.

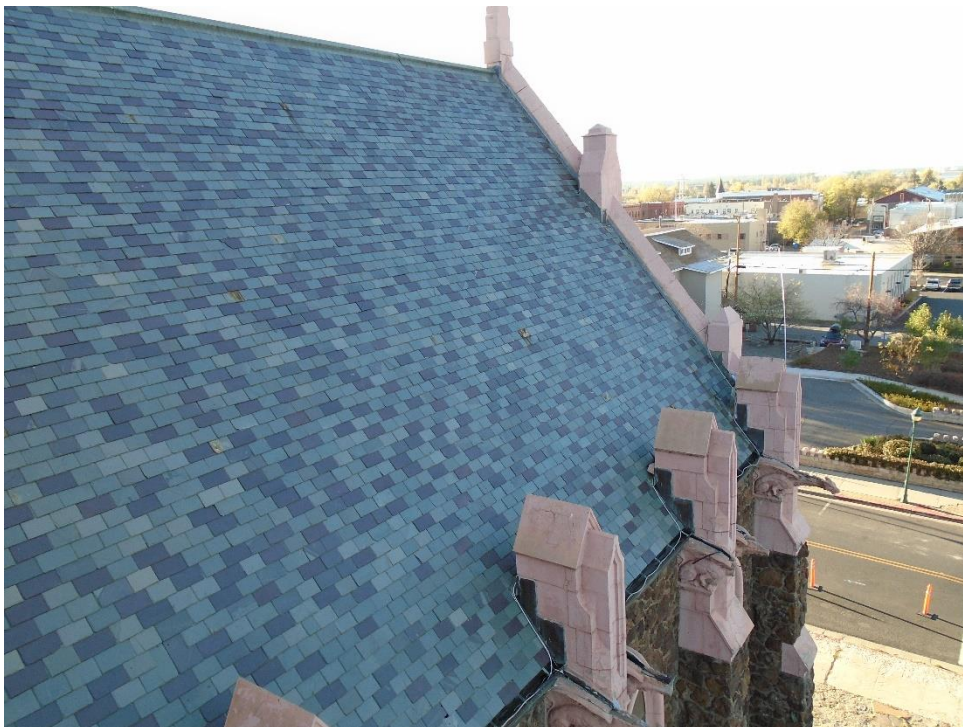
Photo 14

- The steep-slope roofs are primarily covered with multi-colored, slate roof tiles set in a graduated pattern. The roofs generally feature lead coated copper sheet metal ridge caps and open valleys lined with sheet metal. Overall, the slate tiles are in good condition (Photos 14 – 16).

General view of main roof looking south.

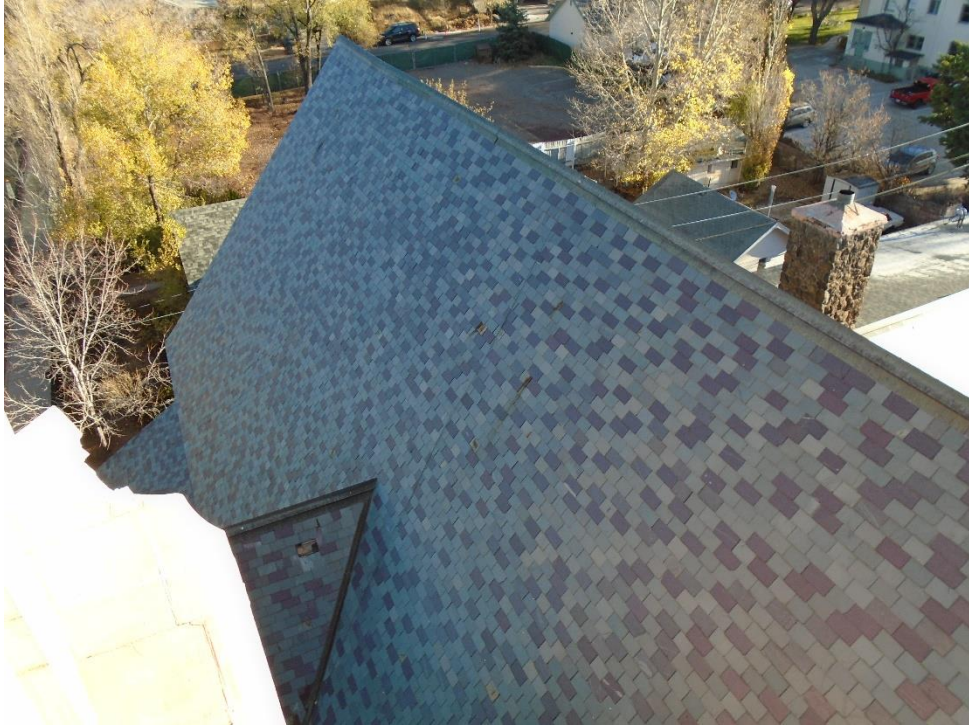
Photo 15

General view of main roof looking north.

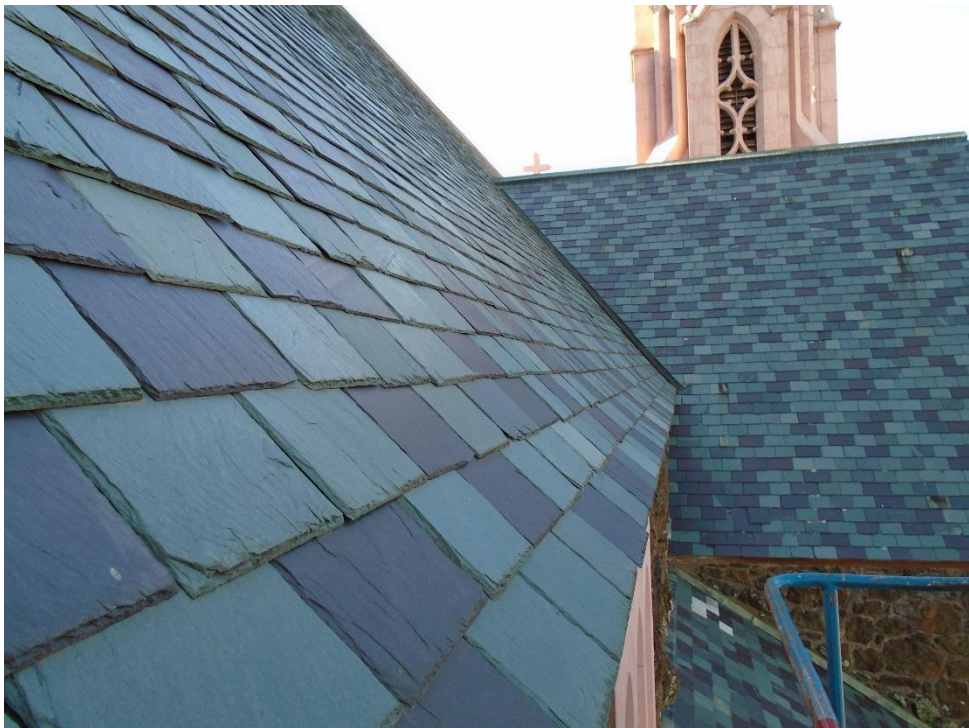
Photo 16

Typical condition of slate tiles.

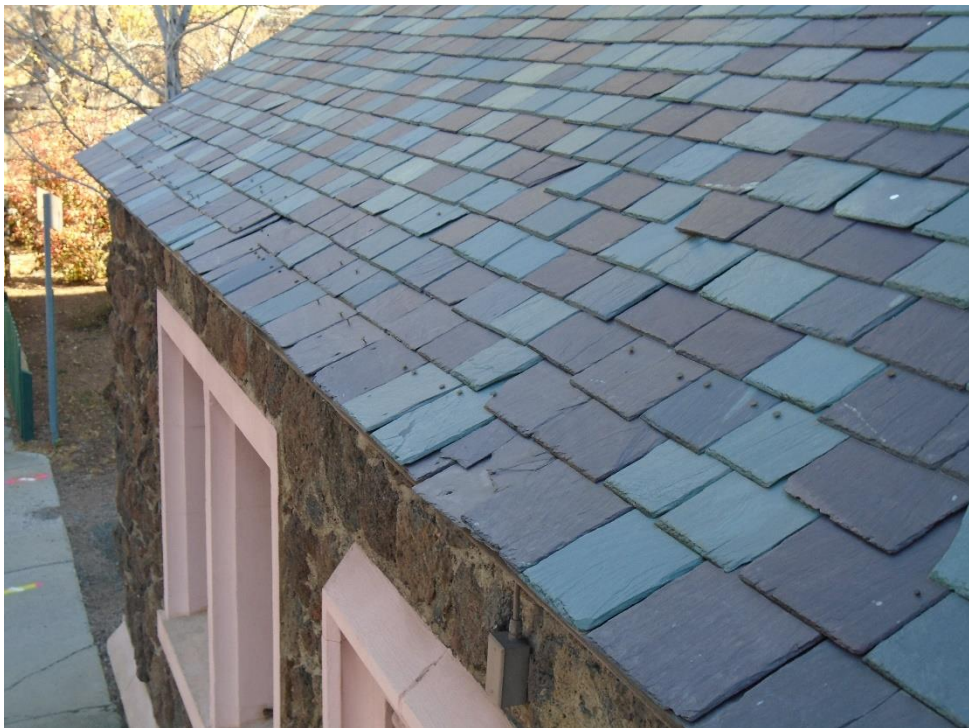
Photo 20

- In isolated locations we observed exposed fasteners through the roof tiles (Photos 19 and 20). Some of the fasteners also appear to be steel (ferrous) roofing nails.

Multiple exposed nail heads in tiles.

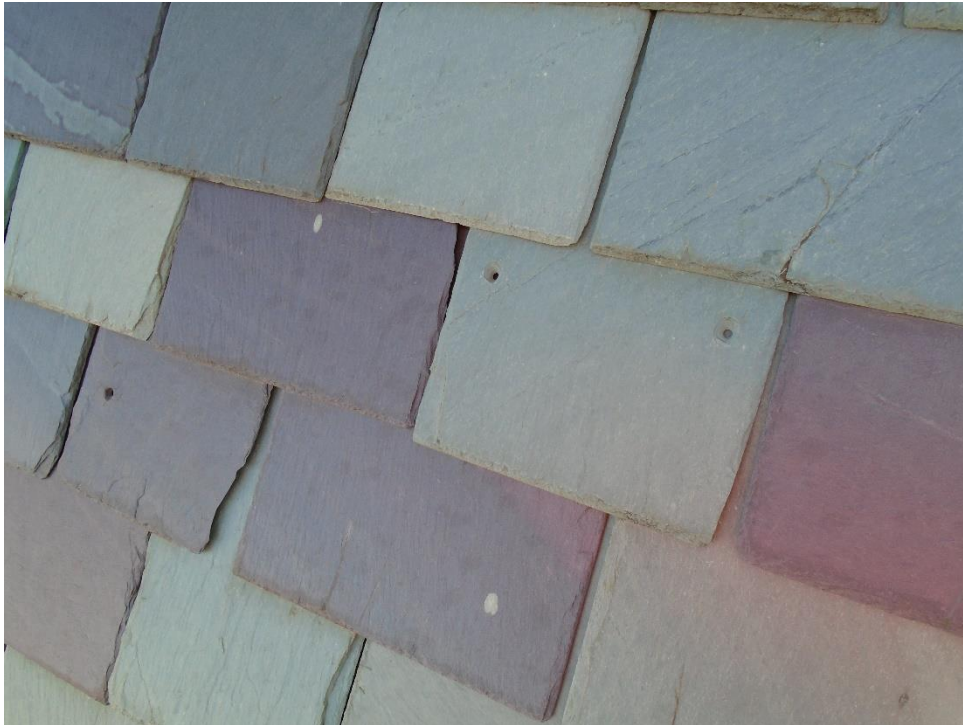
Photo 21

- Broken roof tiles have often been repaired by salvaging, turning, and reinstalling the tiles (Photo 21). The exposed fastening holes are visible in the middle of the exposed face of the tile.

Turned tiles and exposed fastening holes.

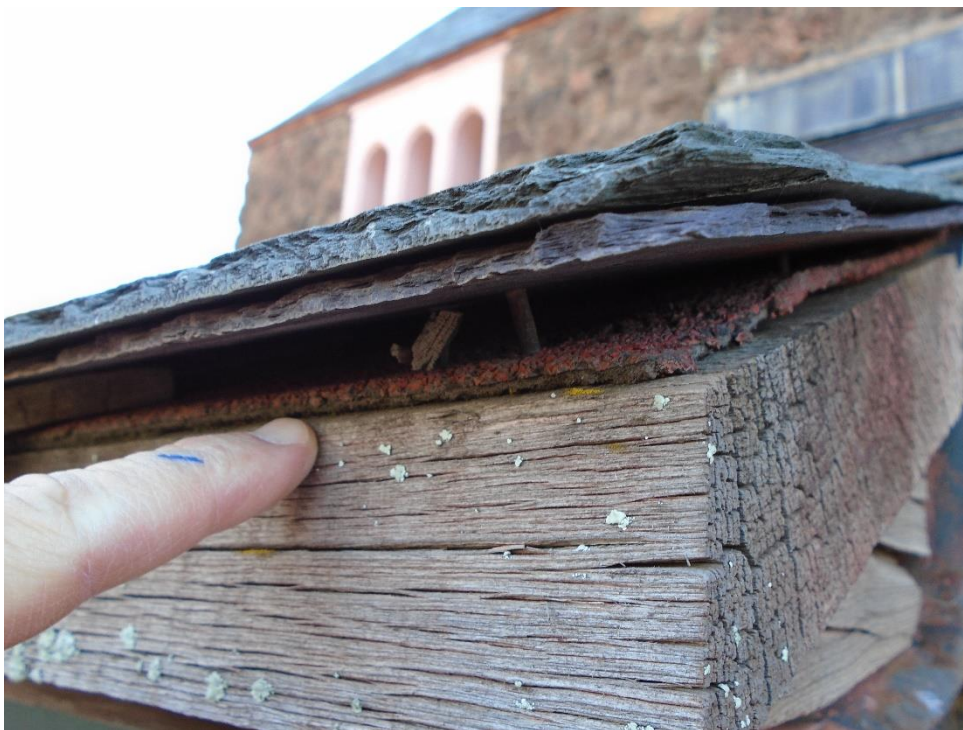
Photo 22

- We observed underlayment under the slate tiles in several locations. The underlayment consisted of (in different locations) either roofing felt or bituminous roofing (Photo 22).

- There are no rake or roof edge flashings at the roof edges. In general, wood fascia boards are fully exposed at these locations (Photos 22 – 24).
- The main roof features a copper sheet metal ridge cap. The ridge cap is buckling and warped in some locations leaving a small gap between the cap and tiles. We observed a split in the sheet metal (Photo 25). There are several unsealed screw fasteners penetrating the surface of the sheet metal.

Bituminous roofing underlayment.

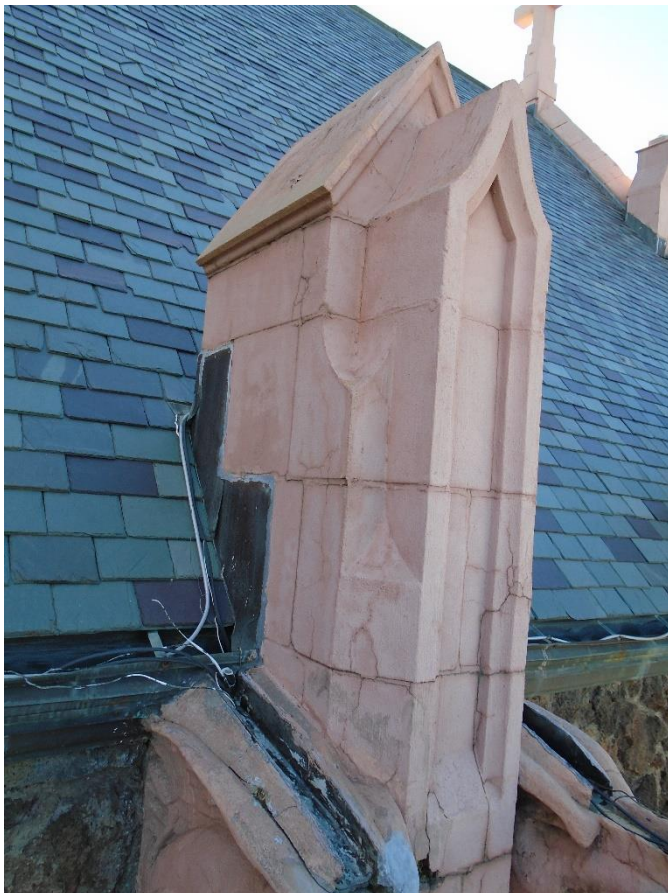
Photo 26

- Confined rakes around buttresses and parapets incorporate sheet metal step counterflashing. The step-flashing is set in recessed, sealant-filled, reglets formed out of the precast stone joints (Photos 26 and 27). The flashing generally was in good condition, but the sealant was in fair to poor condition. Sealant repairs were often surface applied.

Sheet metal step-flashing at confined rakes.

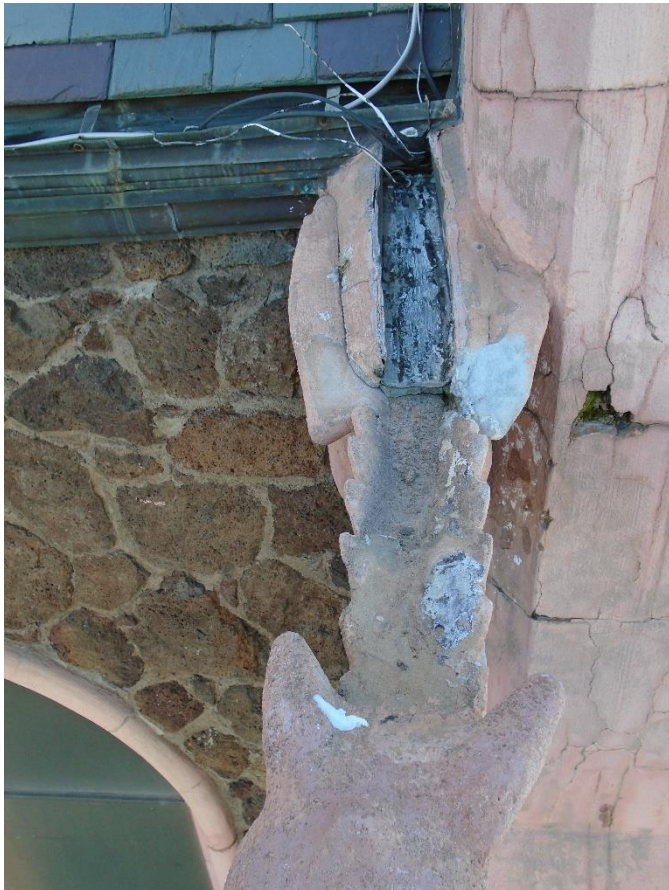
Photo 28

- The main steep-slope gable roof drains into built-in gutters with a copper sheet metal lining. The gutters drain through open sheet metal copper scuppers fed through precast gargoyles (Photo 28). We observed significant staining and some buckling of the metal around the connections of the scupper to the gutters. Some of the connection(s) do not appear to be water tight.

- In some locations, heat-trace wiring in the gutters and scuppers appears to be loose (Photo 28).
- The gutter edges are sagging in the middle of the runs between buttresses and scupper outlets (Photos 29 and 30). There are no snow guards at the eaves (Photo 30), but heat-trace wires are installed in the gutter liners and around the buttress flashing (Photo 31).

Copper sheet metal gutter and scupper.

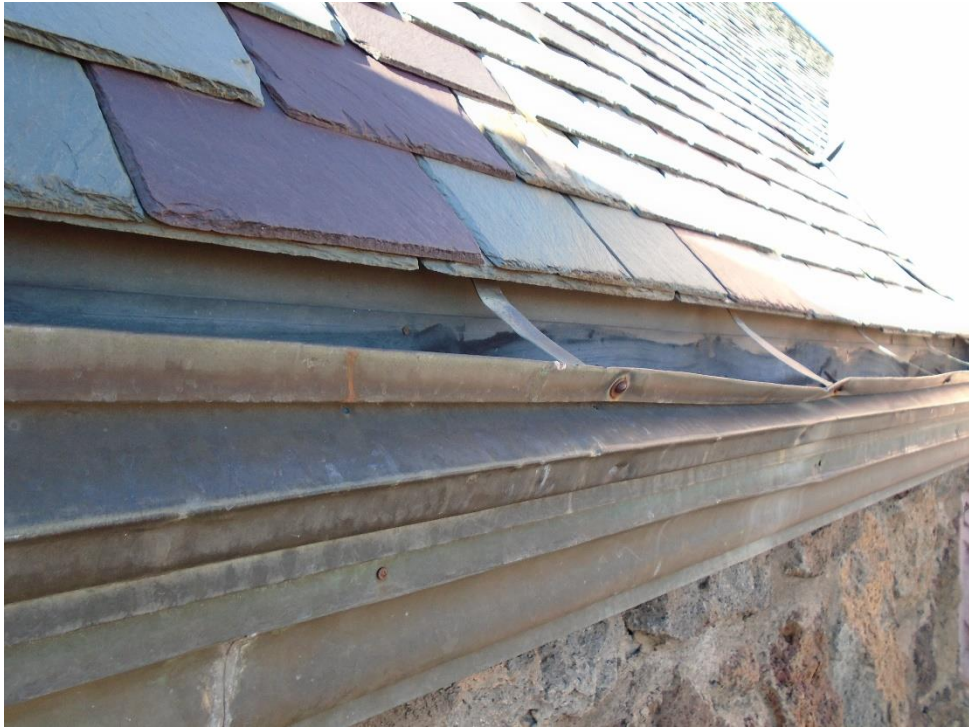
Photo 29

Sagging at the lip of the copper sheet metal gutter on the east elevation.

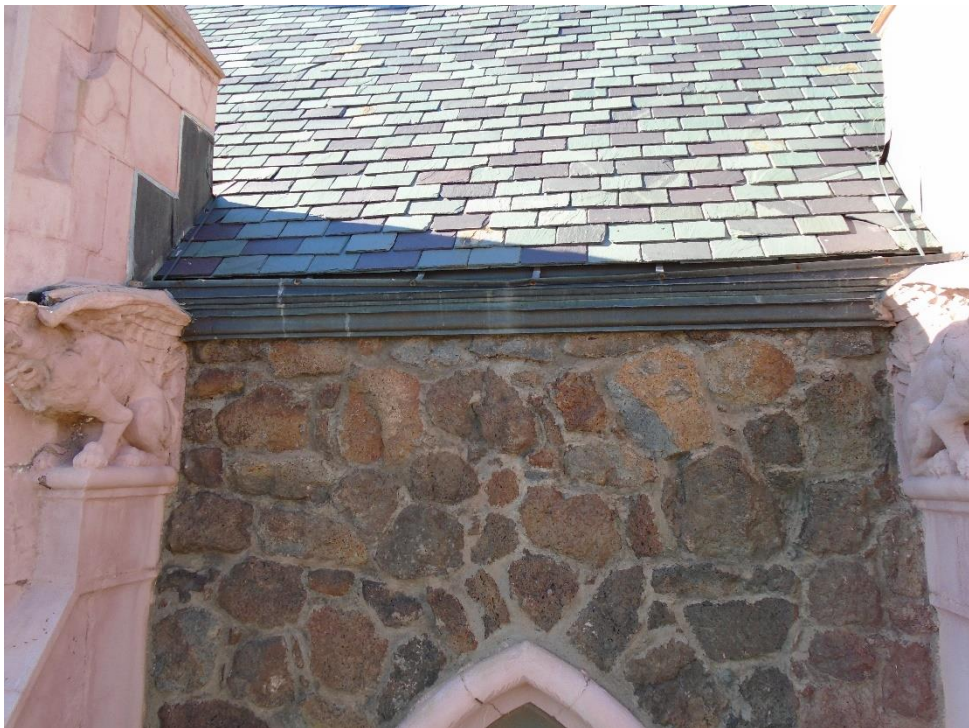
Photo 30

General view of copper gutter.

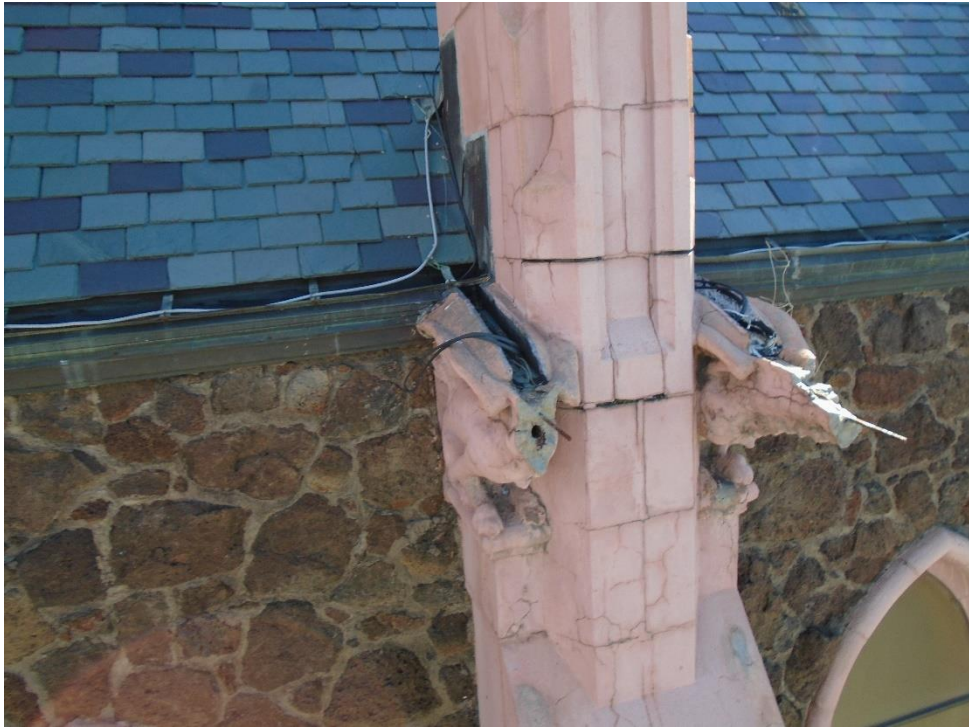
Photo 31
Heat-trace wires.

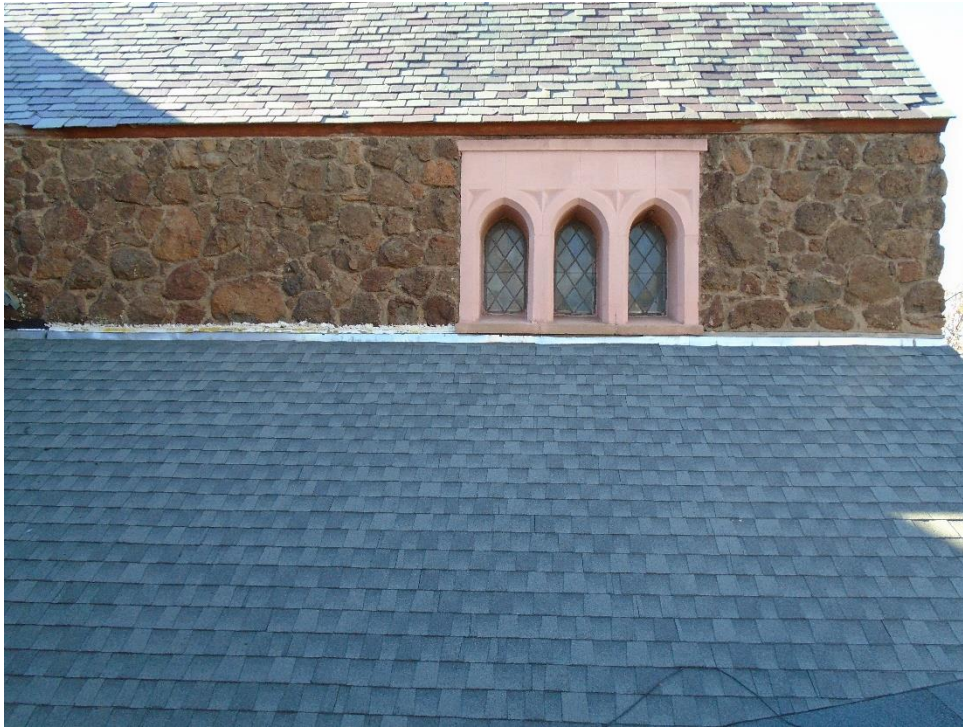
Photo 33

- Vestry rooms appended to the rear of the chapel are covered by steep-slope shed roofs that terminate at the stone walls of the main chapel. The lower roofs are finished with slate tiles (on the west elevation) and asphalt shingles (east elevation) (Photos 32 and 33).

Steep-slope roof at rear of church.

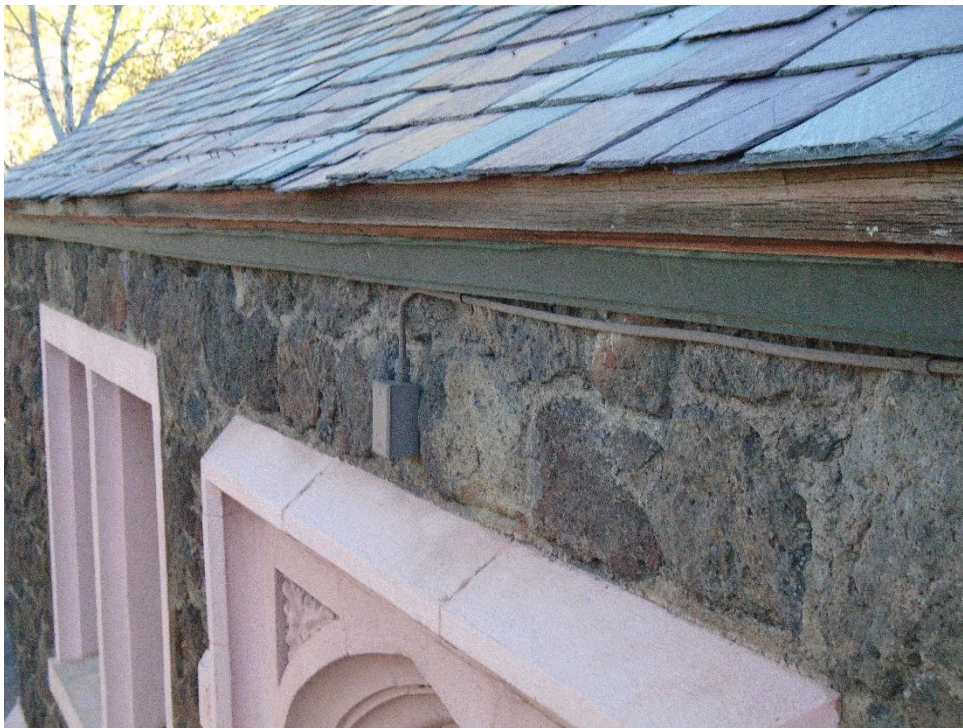
Photo 34

The transept and vestry roofs, and the back portion of the main roof do not incorporate gutters.

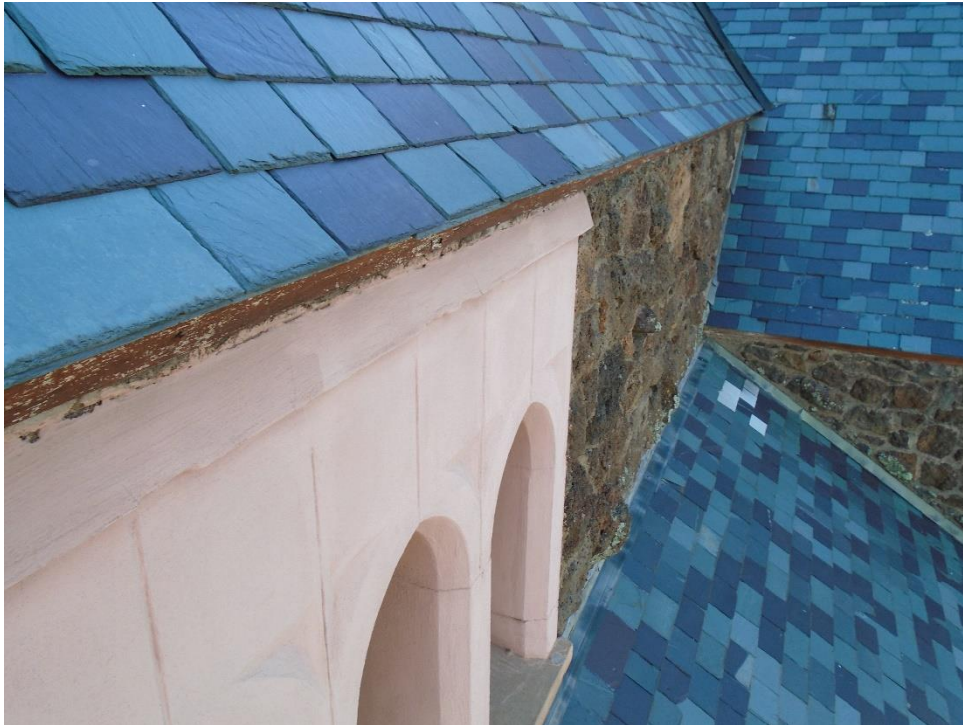
Photo 35

The transept and vestry roofs, and the back portion of the main roof do not incorporate gutters.

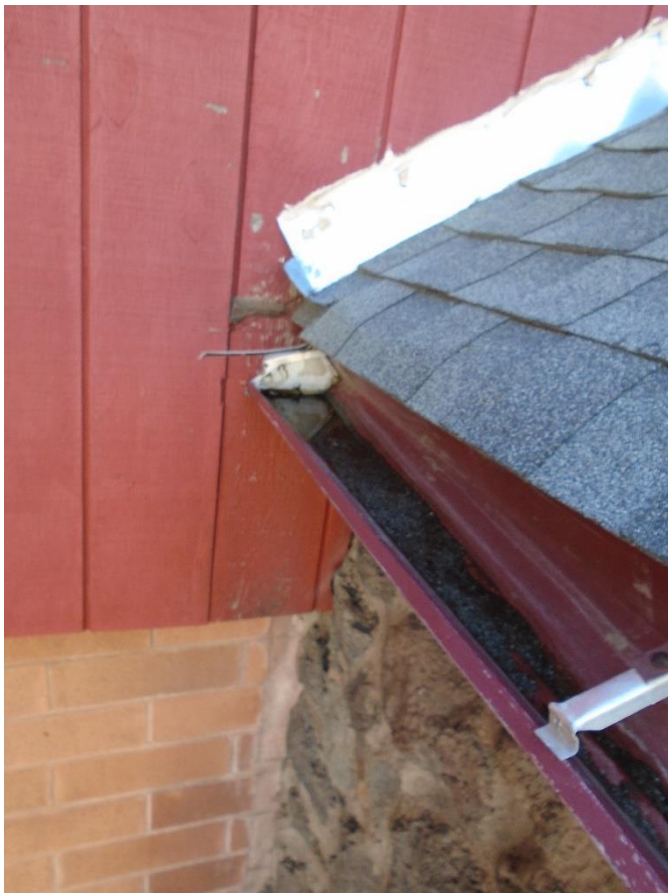
Photo 36

- A portion of the vestry roof on the east elevation drains to a gutter that has become detached and now maintains a negative slope from the outlet (Photo 36).

A detached and negative sloped hung gutter.

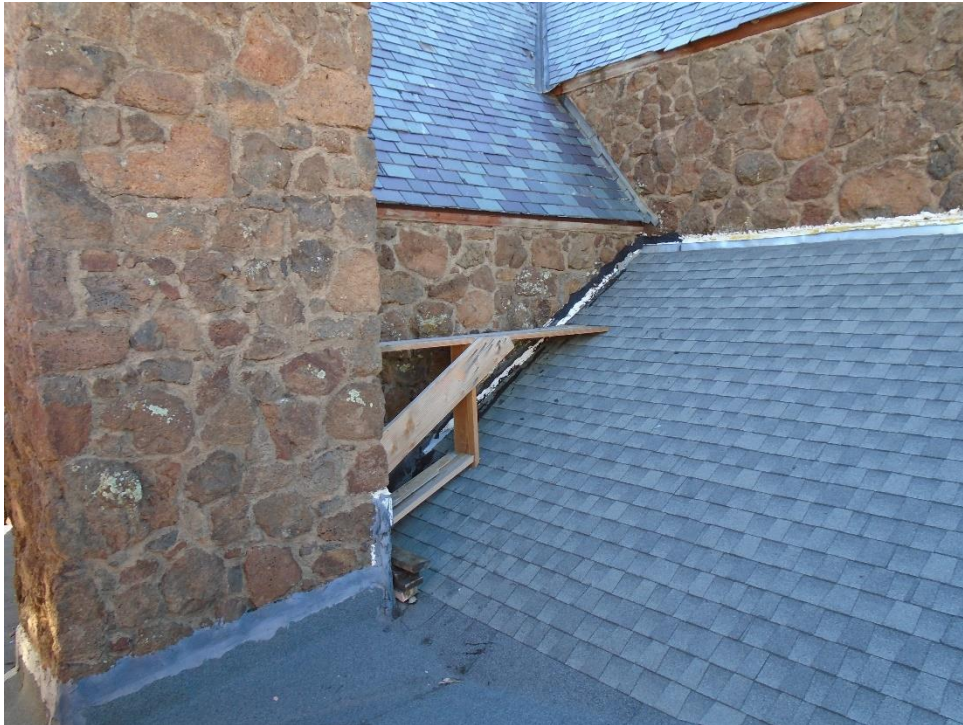
Photo 37

Flashing conditions at intersection of roofs-to-walls.

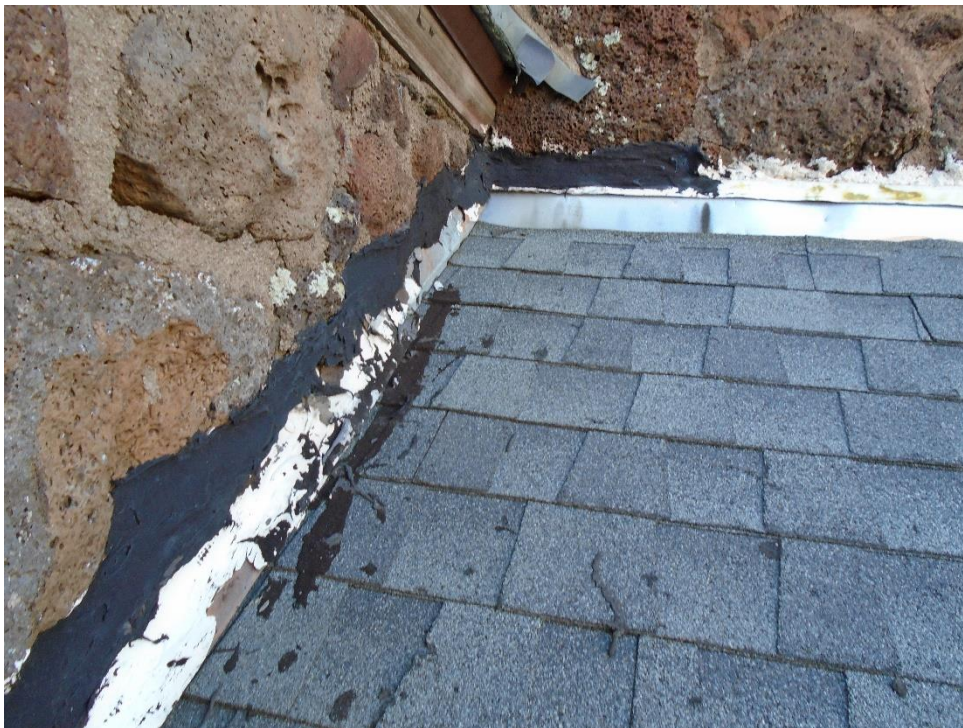
Photo 38

Flashing conditions at intersection of roofs-to-walls.

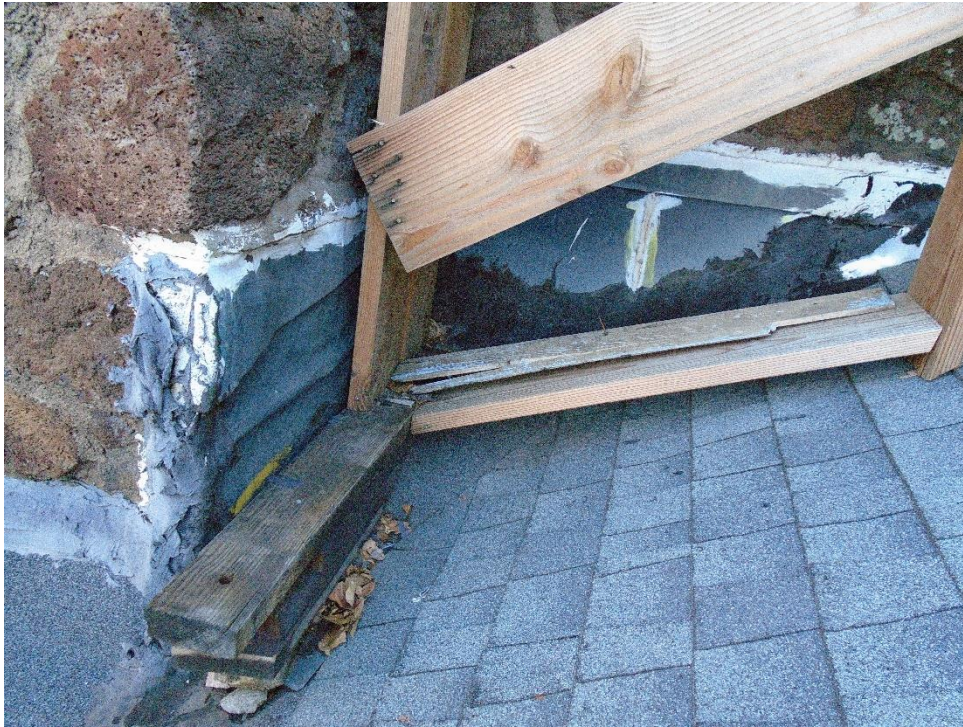
Photo 39

Flashing conditions at intersection of roofs-to-walls.

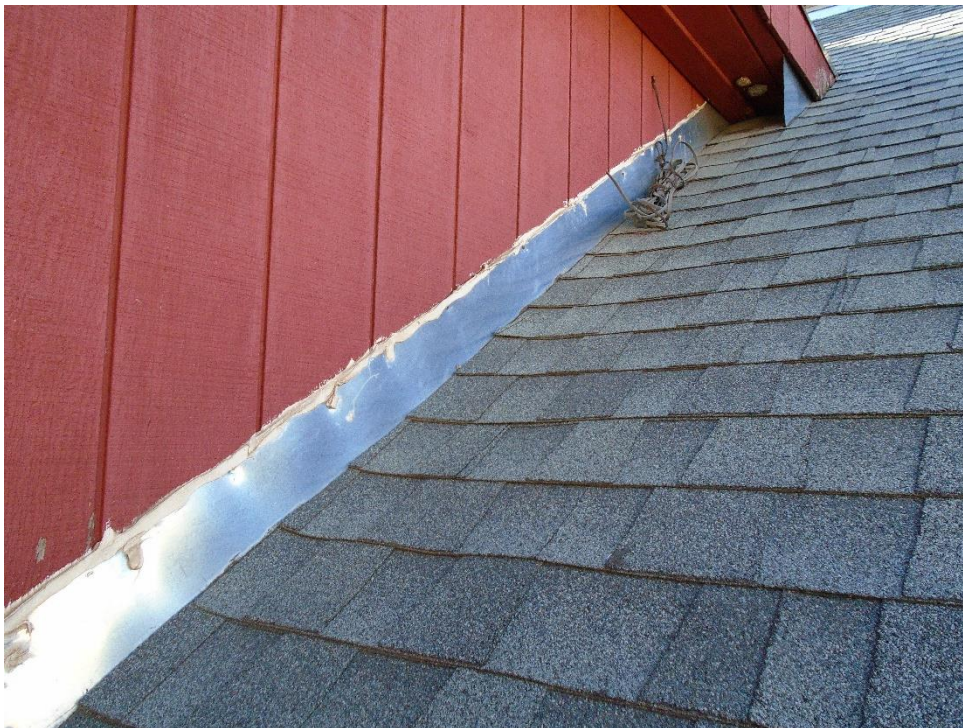
Photo 40

Flashing conditions at intersection of roofs-to-walls.

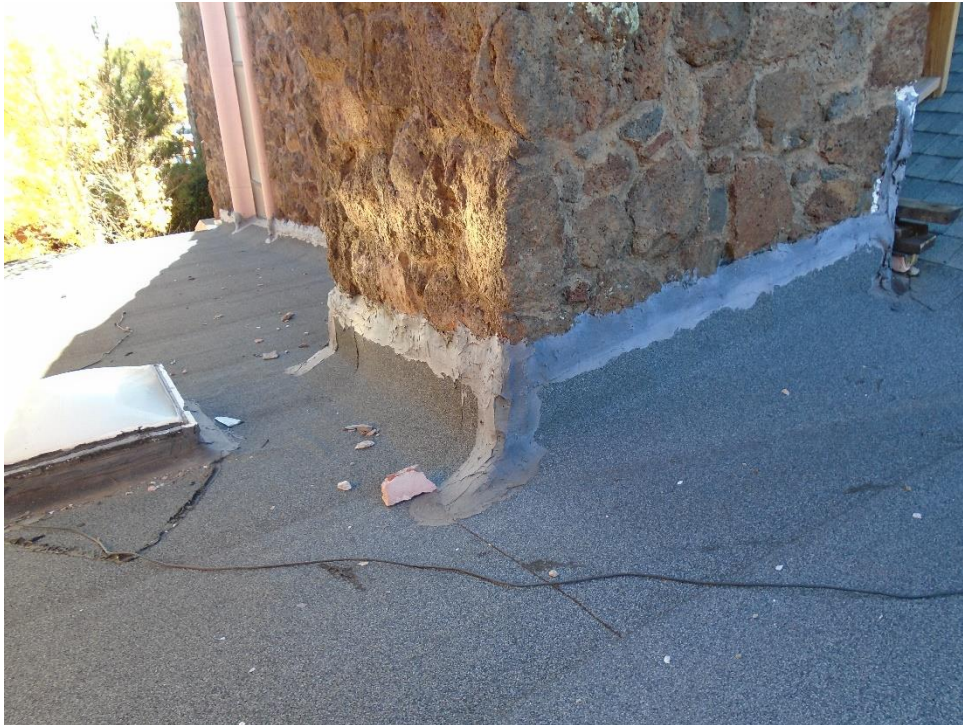
Photo 41

- In general the built-up roof membranes are in good condition however, the membrane systems do not contain distinct base flashings or sheet metal counterflashings (Photos 41 and 42).

Large low-slope roof on the north east side of church.

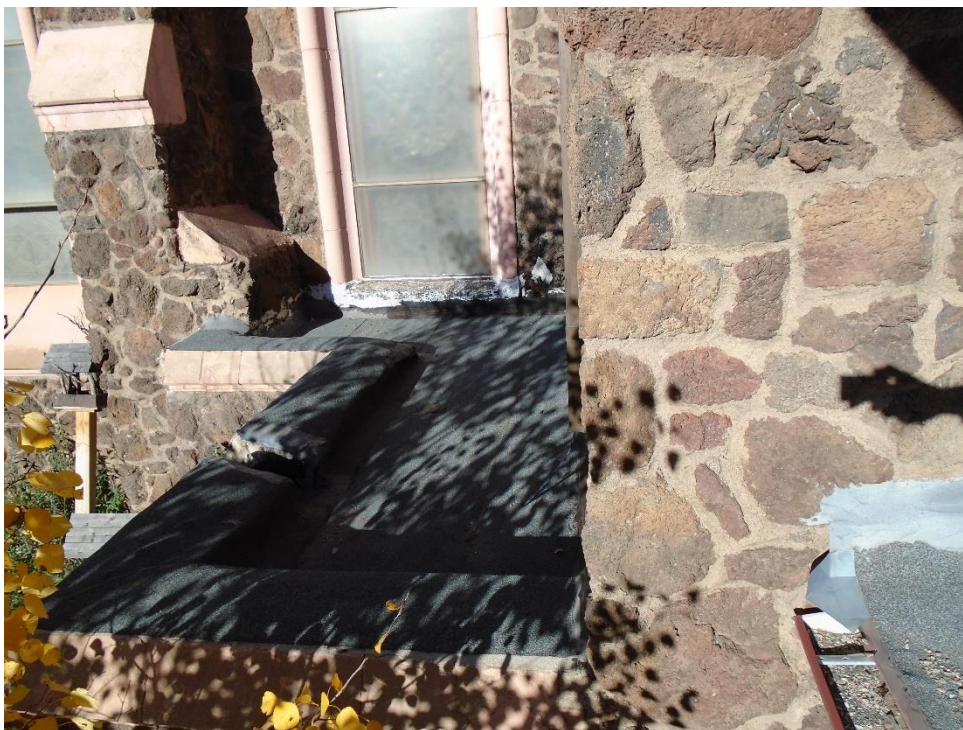
Photo 42

Small low-slope roof on the north east side of church.

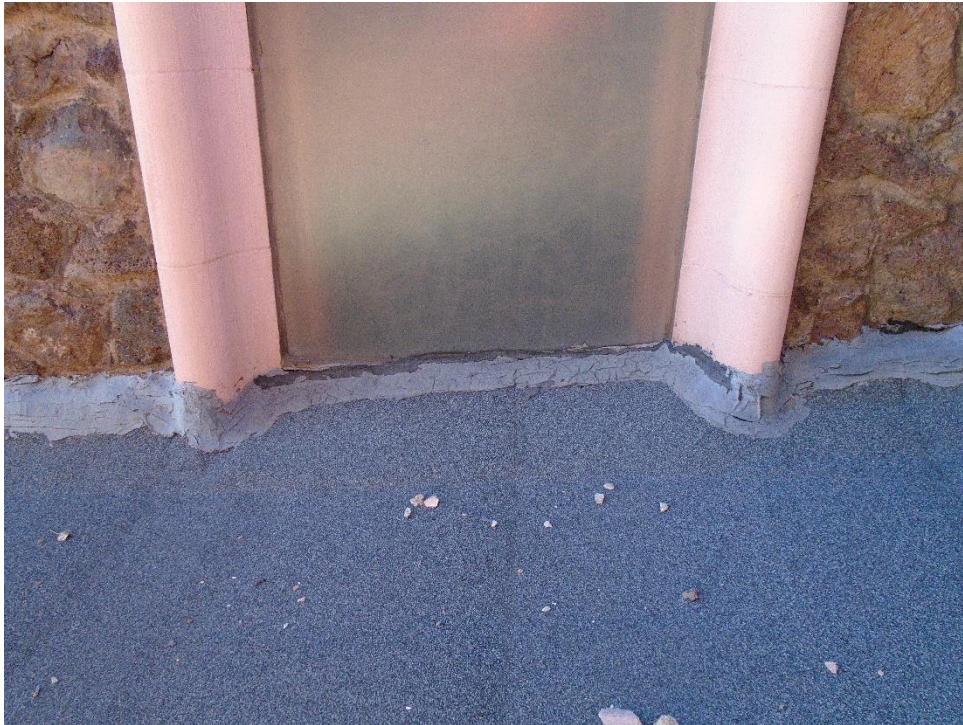
Photo 43

Liquid counterflashing
and/or grey roof mastic.

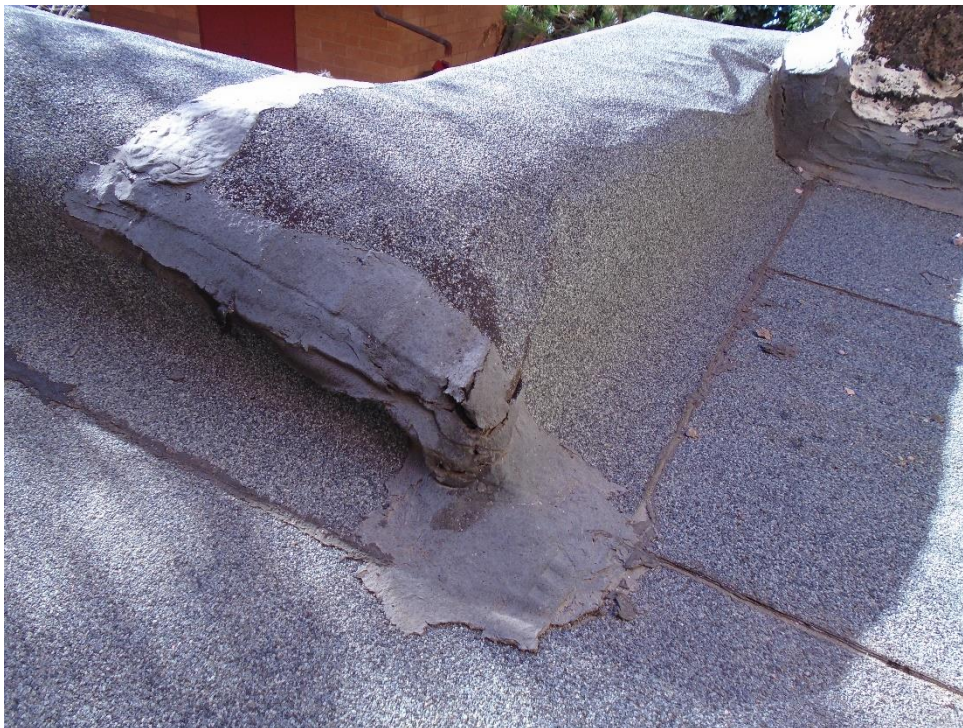
Photo 44

The roof membrane laps
up and on top of a parapet
wall.

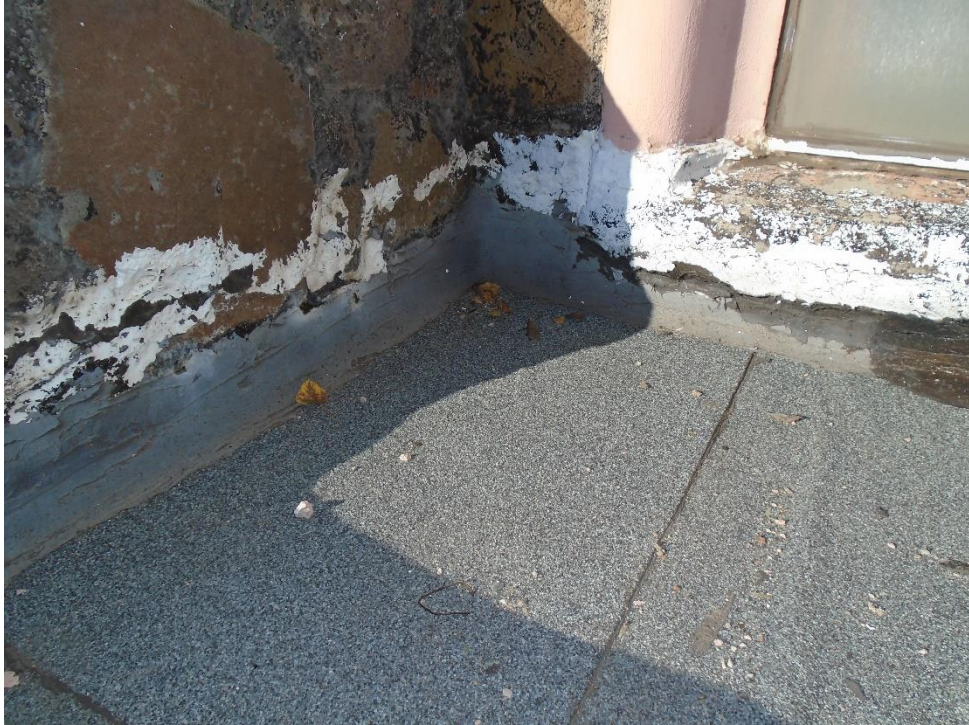
Photo 45

Patching of the roof membrane counterflashing.

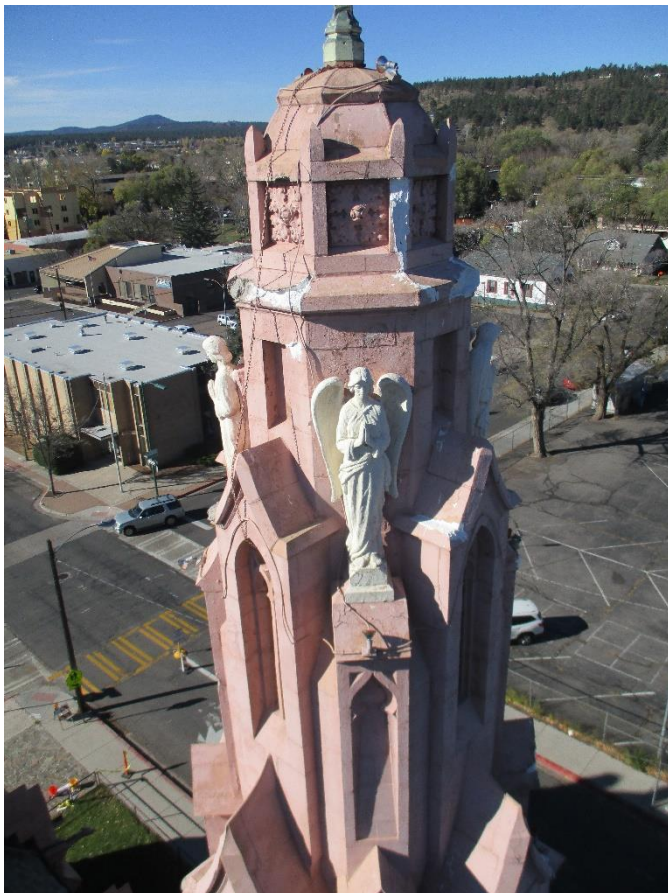
Photo 48

Typical view of bell tower.

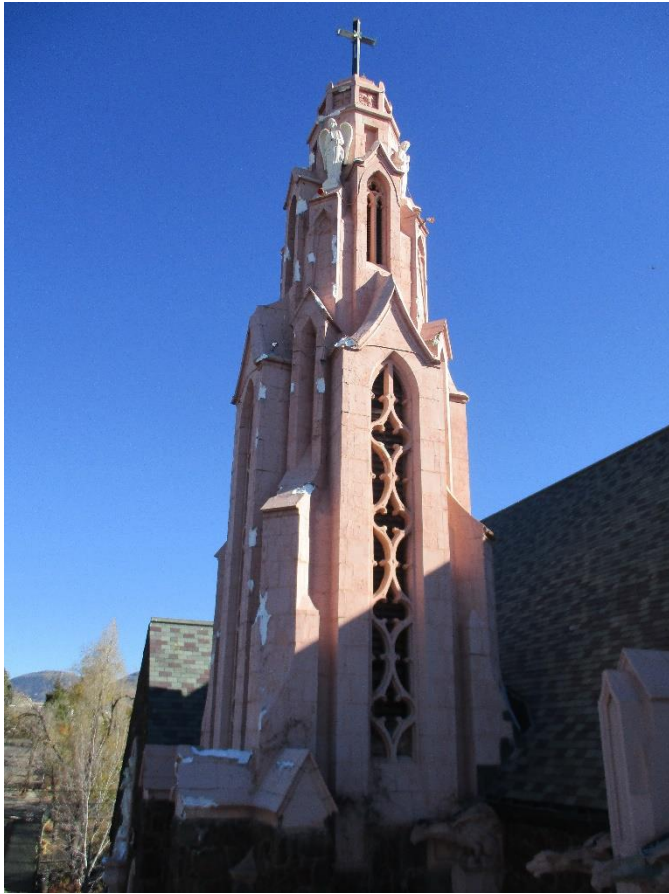
Photo 49

Typical view of bell tower.

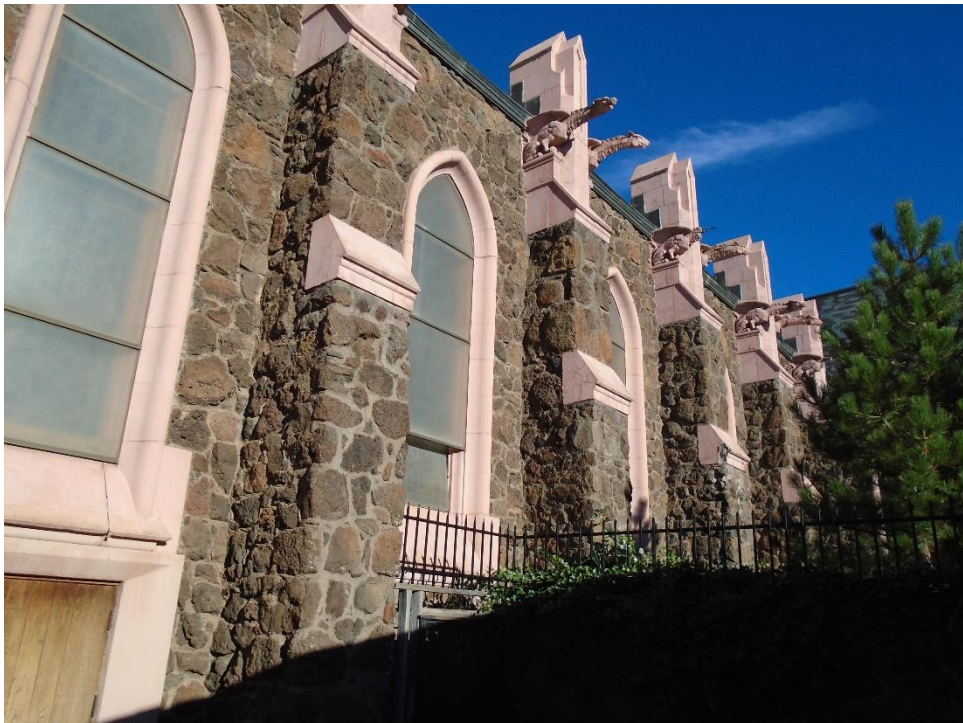
Photo 50

Precast concrete ornamentation.

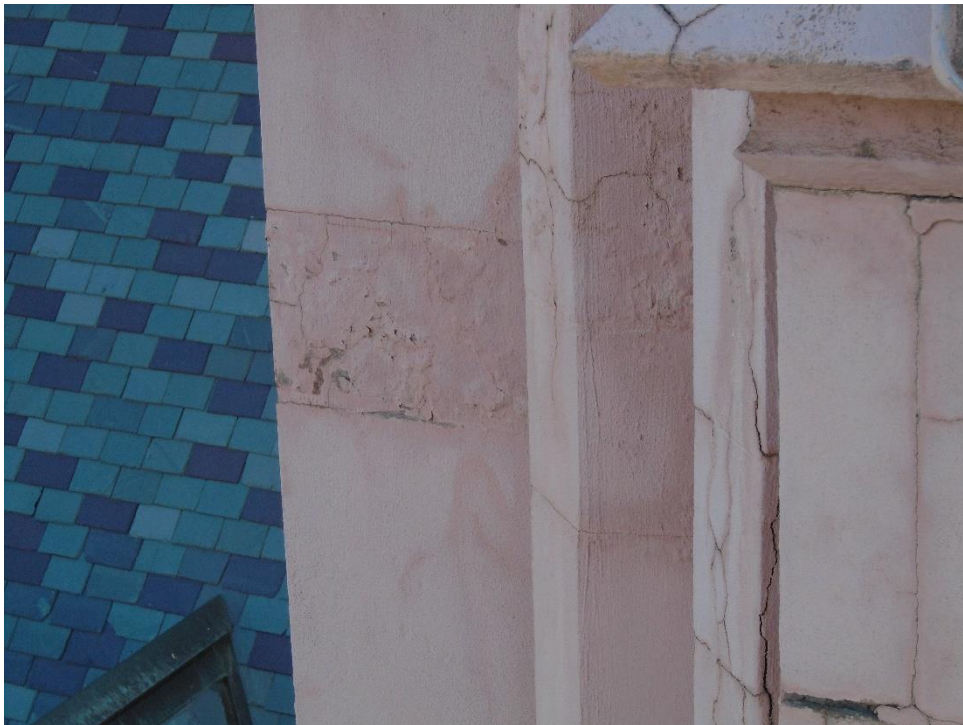
Photo 70

Bubbling and peeling paint coating.

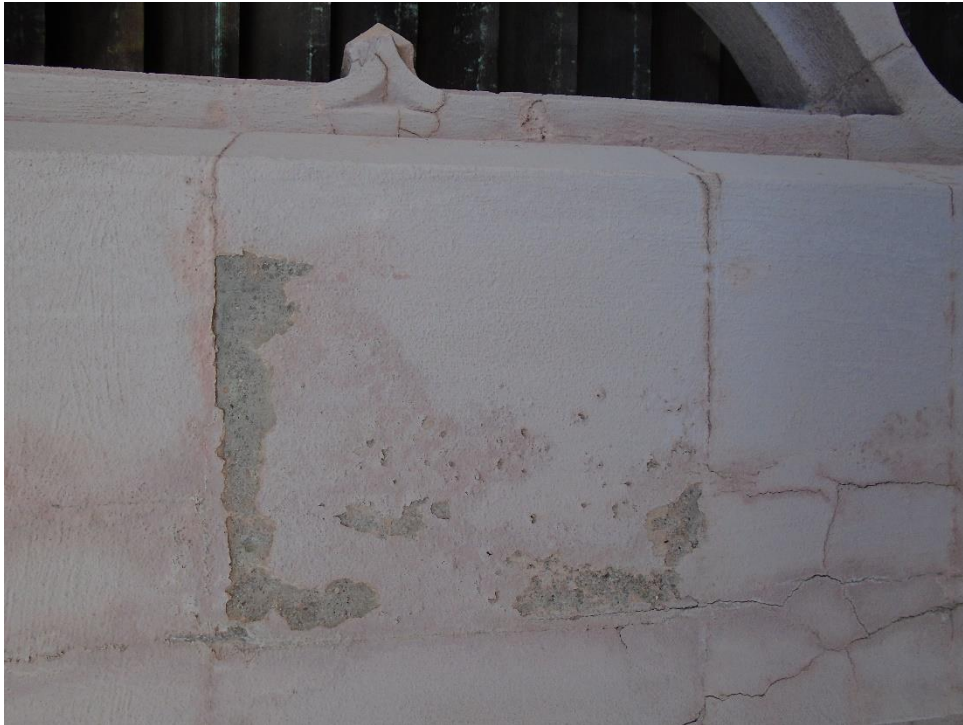
Photo 71

Peeling paint coating.
