FACADE
REHABILITATION
PRE-DESIGN
INVESTIGATION AND
CONDITIONS
ASSESSMENT

Nativity of the Blessed
Virgin Mary Chapel
Flagstaff, Arizona
1 May 2017

SGH Project 167283

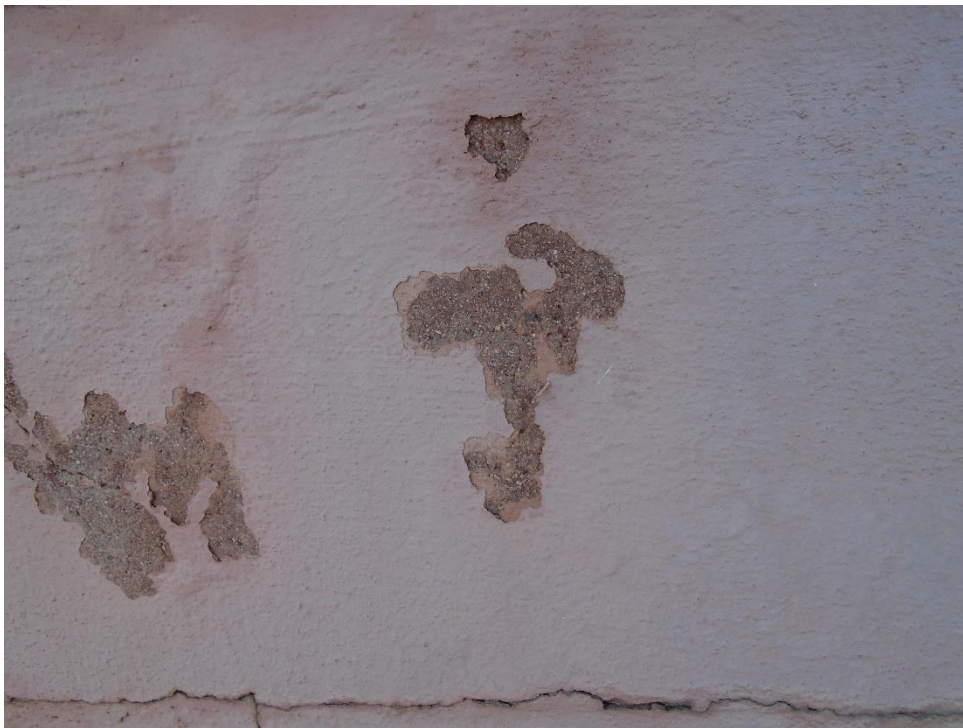
Photo 72

Peeling paint coating
showing multiple layers.

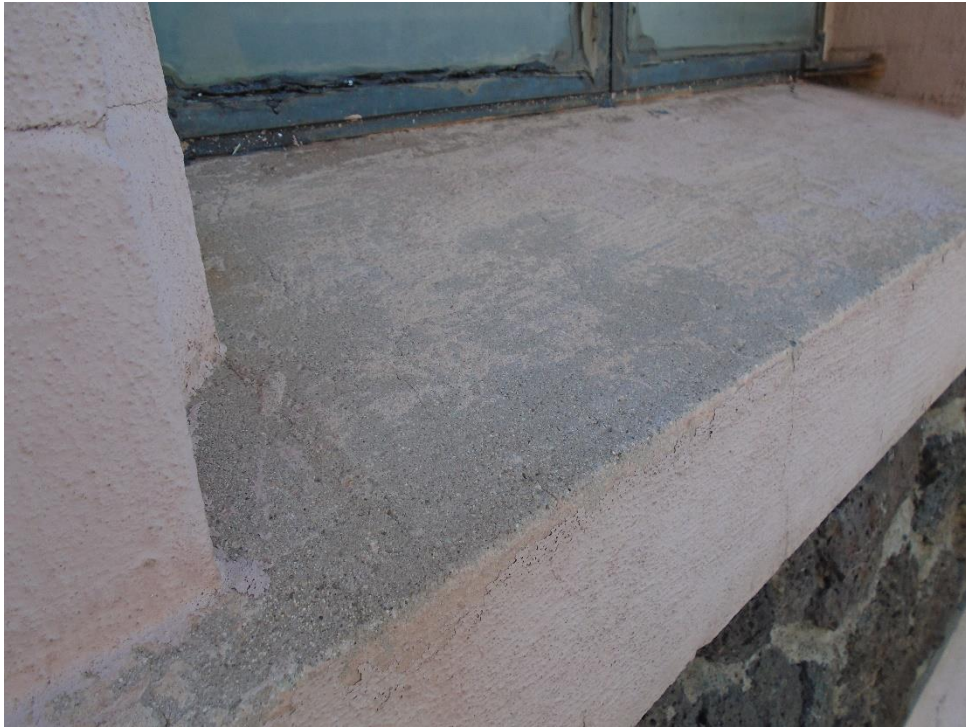
Photo 73

Peeling and eroded paint at window sill.

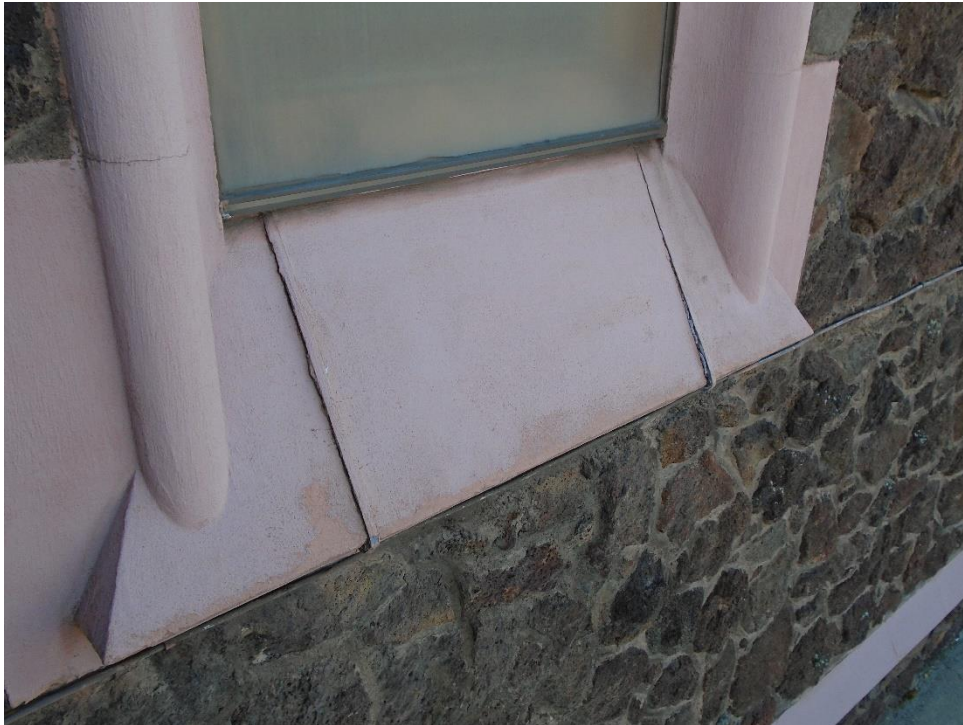
Photo 74

Deteriorated mortar joints.

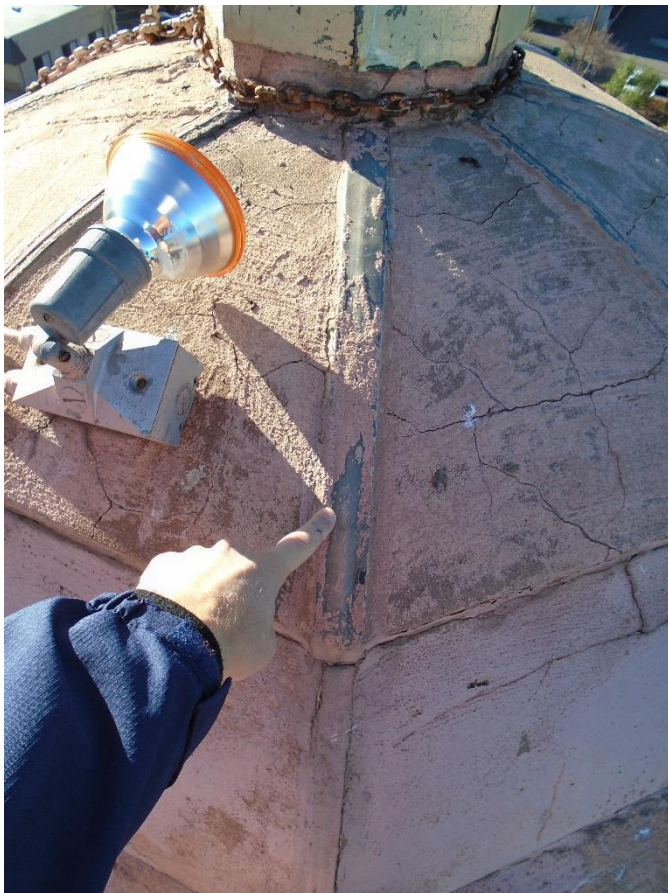
Photo 75

Lead joint covers (painted over) set in sealant or mortar.

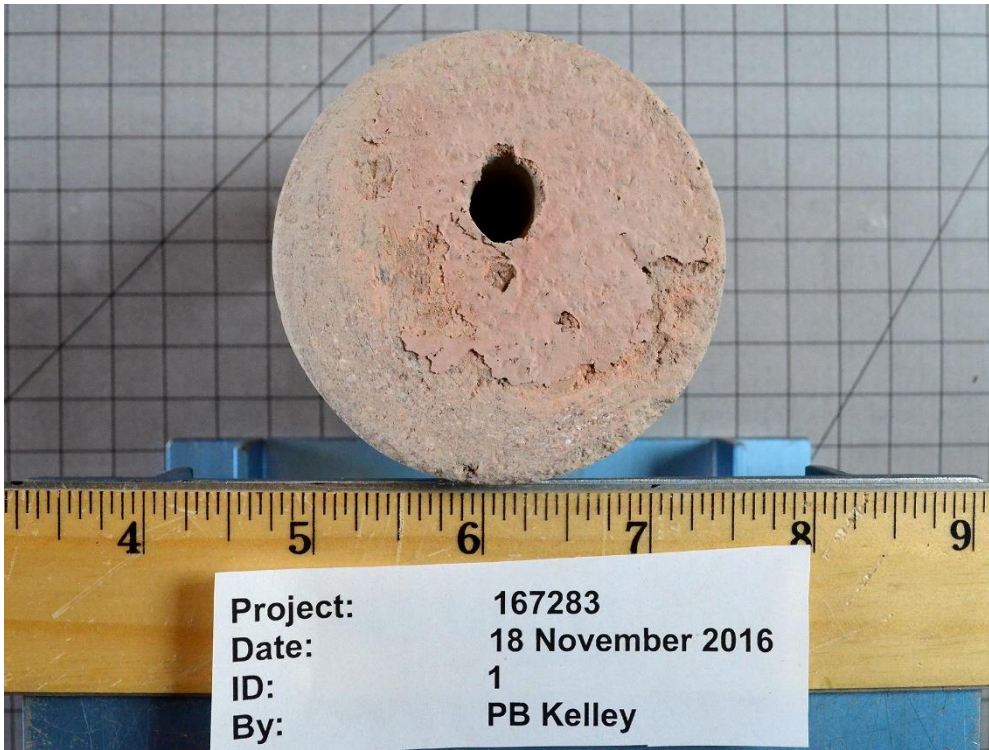
Photo 1

Three of the samples (Sample 1, Sample 2, and Sample 3) are nominal 2-3/4 in. diameter partial depth cores (Photos 1 through 6). On each of the three cores, one end exhibits a painted, formed face and the other end is an uneven, fractured face resulting from sample removal. The core samples were reportedly drilled horizontally with the painted, formed faces representing the exposed surface of the concrete. Both Sample 2 and Sample 3 were received in two pieces, reportedly because the samples broke during coring. Sample 5 is a saw-cut block with approximate dimensions of 5 in. by 4 in. by 2-1/2 in. and includes a painted, formed exterior face (Photos 7 and 8). Sample 5 was reportedly cut from one of the gablets of the structure that had been removed and left on the ground adjacent to the structure.

Exterior face of Sample 1.

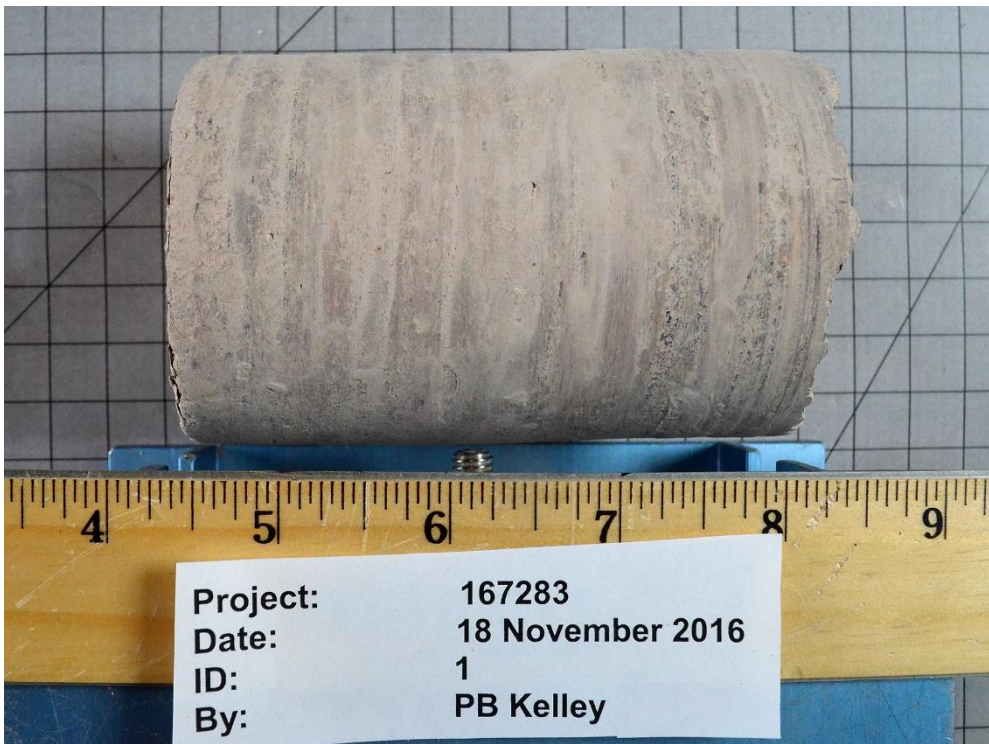
Photo 2

Side view of Sample 1. The exterior face of the core is to the left.

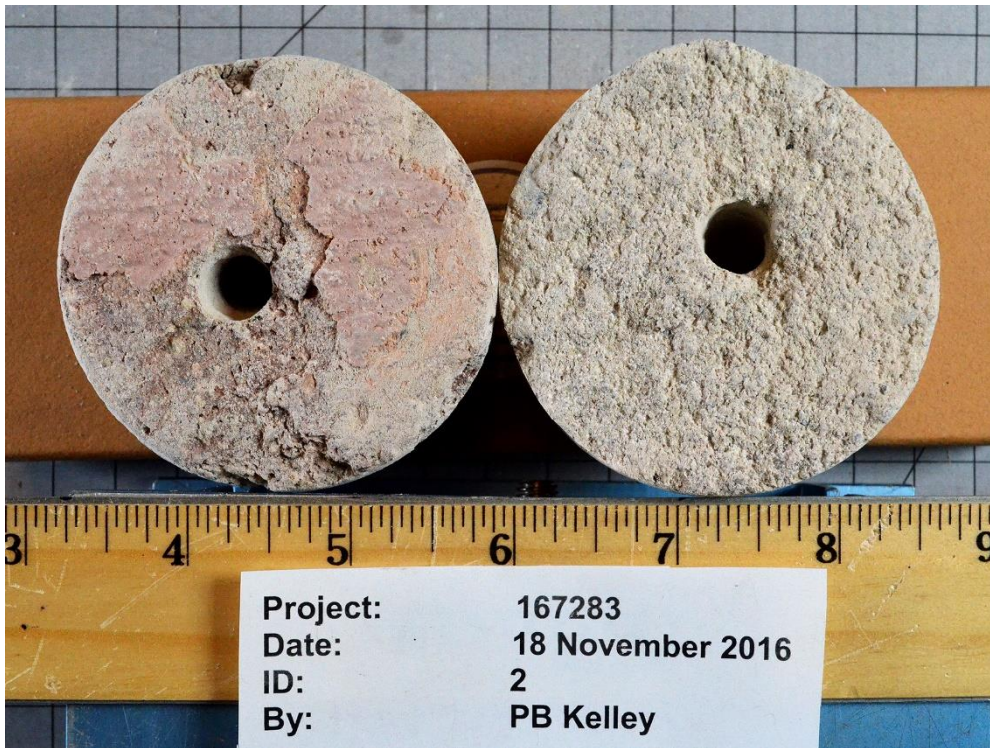
Photo 3

Exterior face of Sample 2 (left) and face of mid-depth fracture (right).

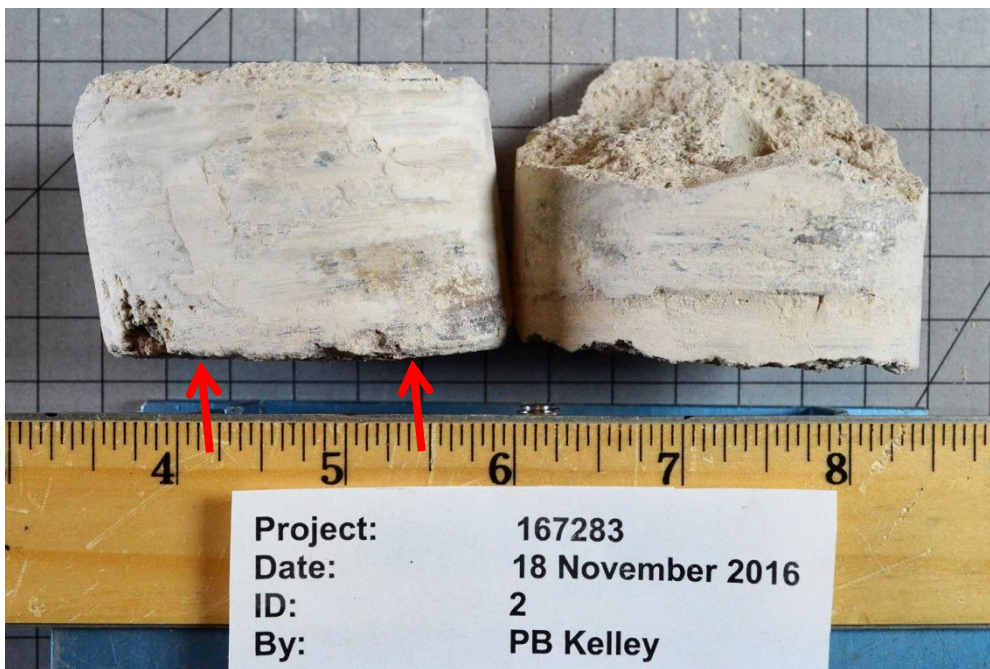
Photo 4

Side view of the pieces of Sample 2. The red arrows point to the exterior face.
